# Vivante HOA

## Level 1 Reserve Study

**Report Period – 01/01/2019 – 12/31/2019**

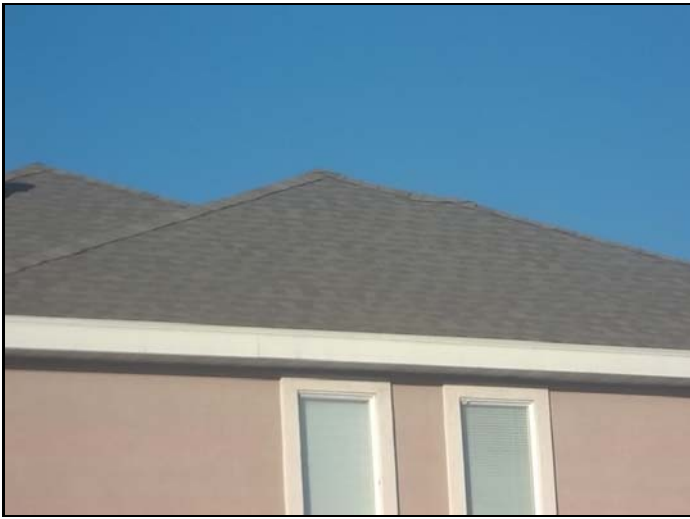
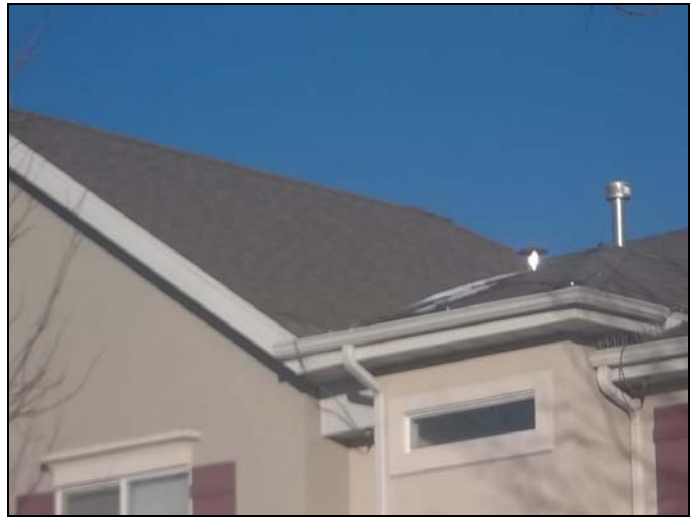
Comp #: 105 Roofs - Replace

The roofs are in fair condition. We recommend funding to replace this component approximately every 20 - 25 years. Remaining life based on average age.

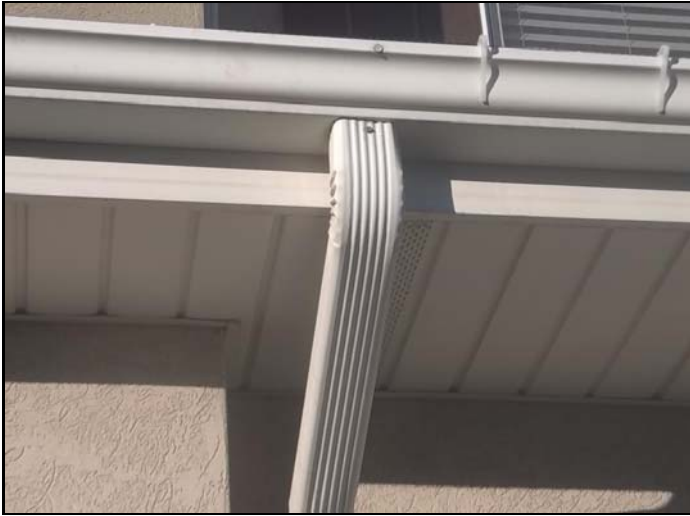
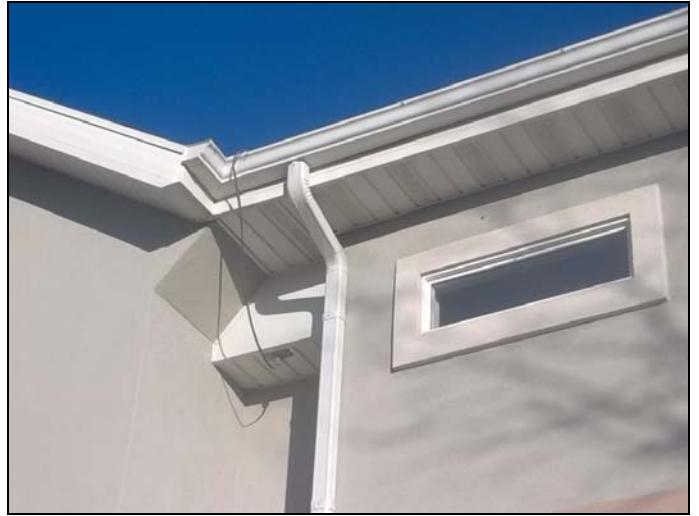
Comp #: 120 Rain Gutters/Downspouts - Replace

The rain gutters and downspouts are in good to fair condition. We recommend funding to replace this component approximately every 25 - 30 years. Remaining life based on average age.

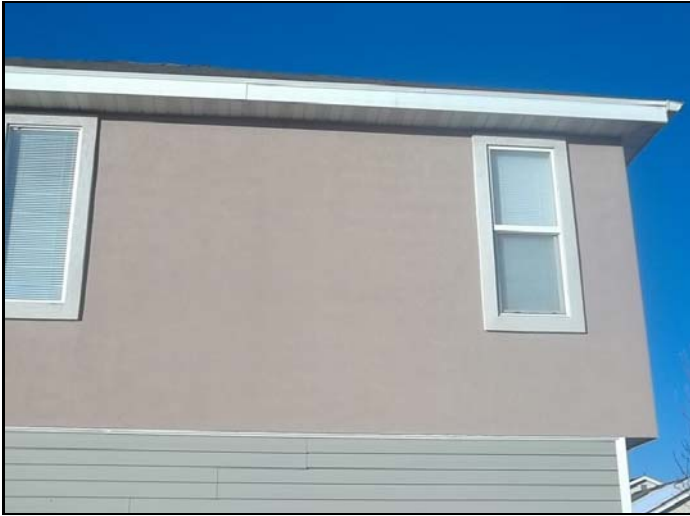
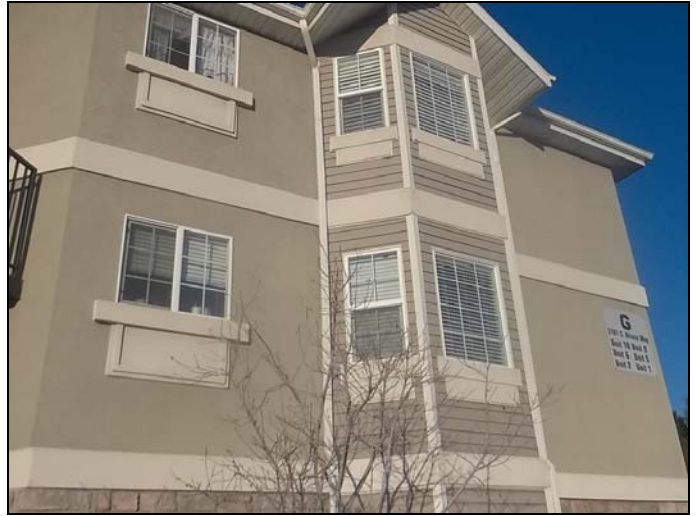
Comp #: 201 Stucco Surfaces - Repair/Repaint

The stucco surfaces are in good to fair condition. We recommend funding to repair/repaint this component approximately every 12 - 15 years. Remaining life based on current age.

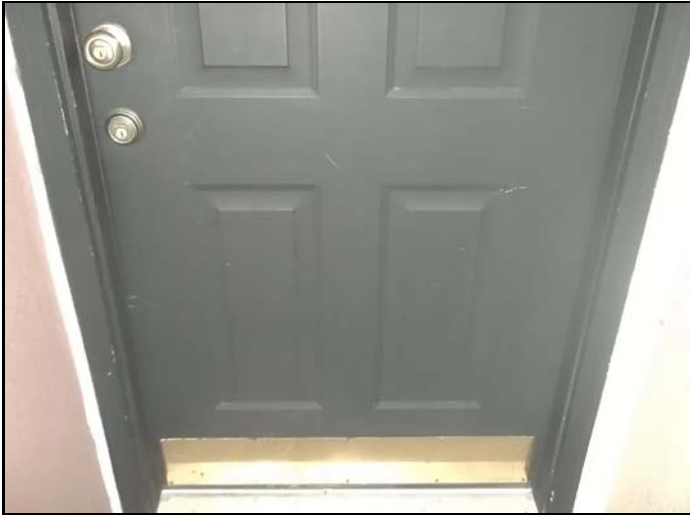
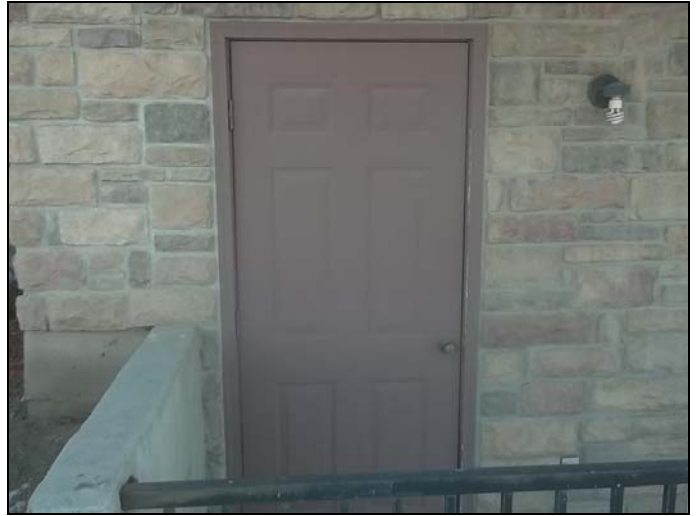
Comp #: 204 Doors - Repaint

*Location:* **Building Exteriors**

*Quantity:* **(288) Doors**

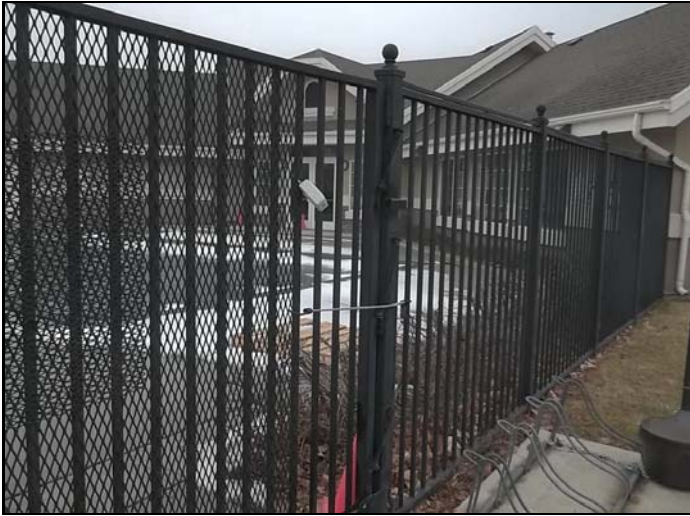
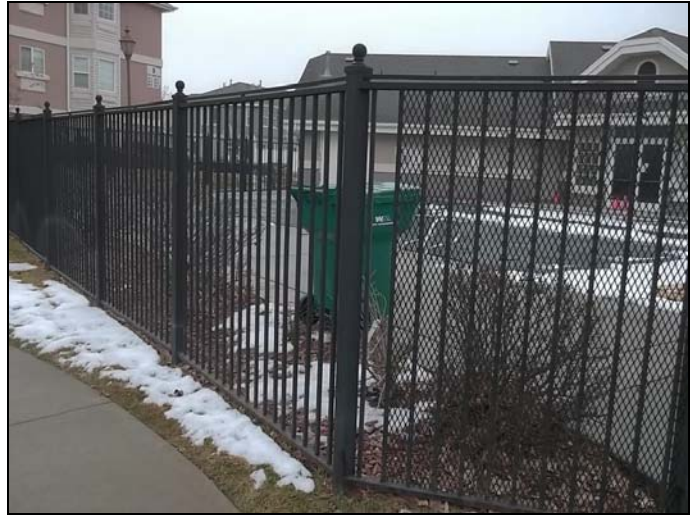
Comp #: 207 Metal Fencing - Repaint

*Location:* **Pool Area**

*Quantity:* **Approx 130 Linear ft.**

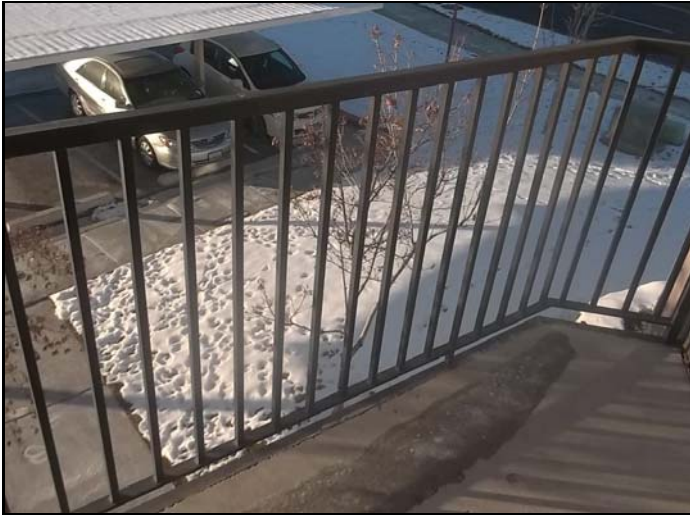
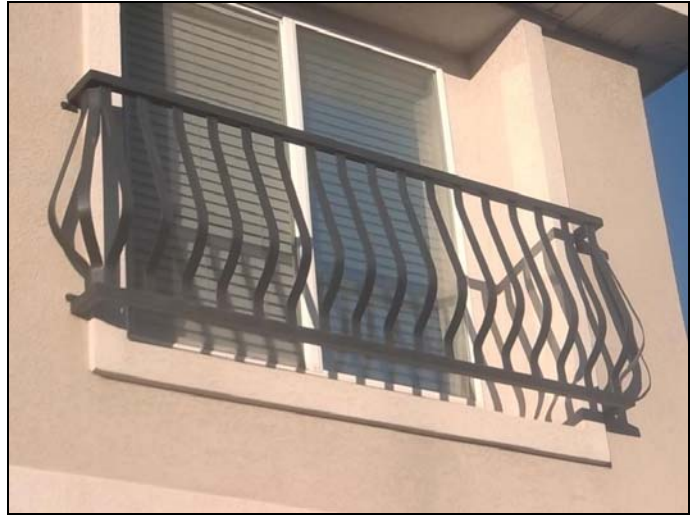
Comp #: 212 Metal Railing - Repaint

*Location:* **Balconies, Stairwells & Windows**

*Quantity:* **Approx 4,260 Linear ft.**

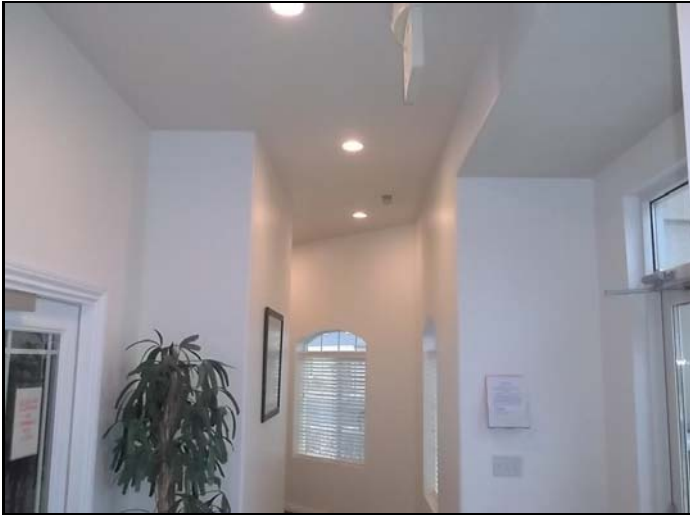
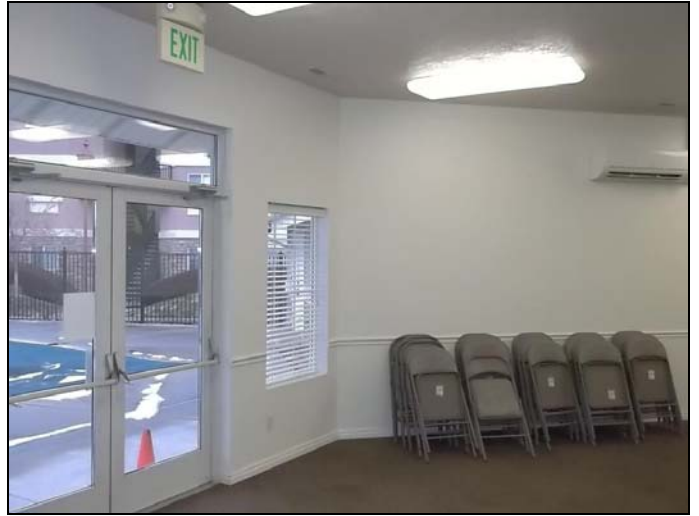
Comp #: 216 Interior Surfaces - Repaint

*Location:* **Clubhouse Interior**

*Quantity:* **Approx 7,290 Sq.ft.**

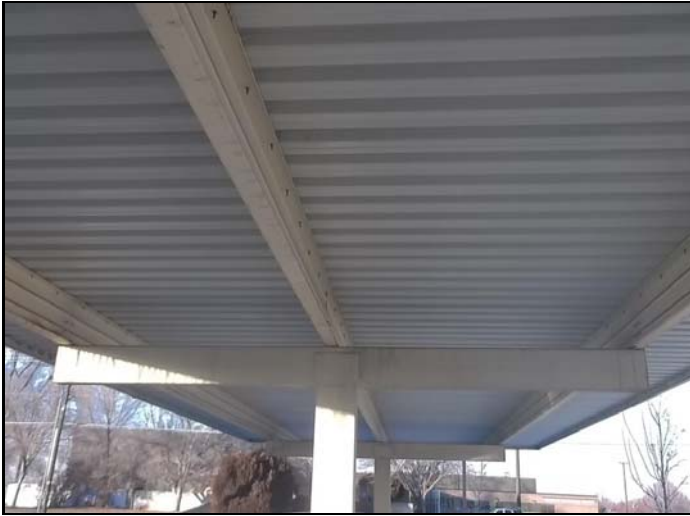
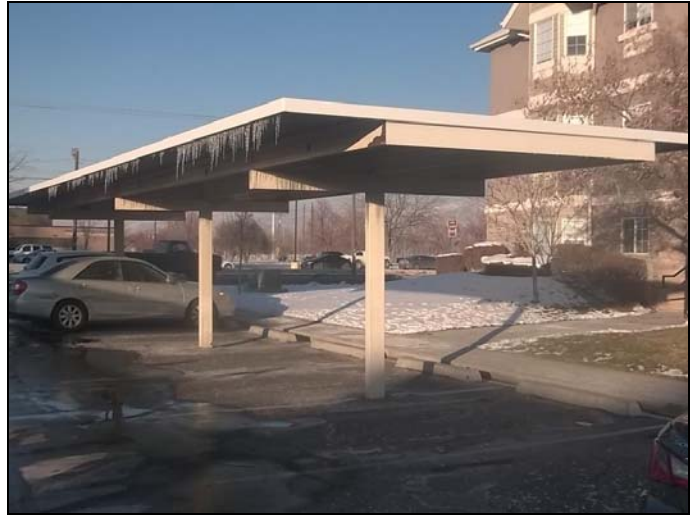
Comp #: 223 Carports - Repaint

*Location:* Carports

*Quantity:* Approx 990 Linear ft.

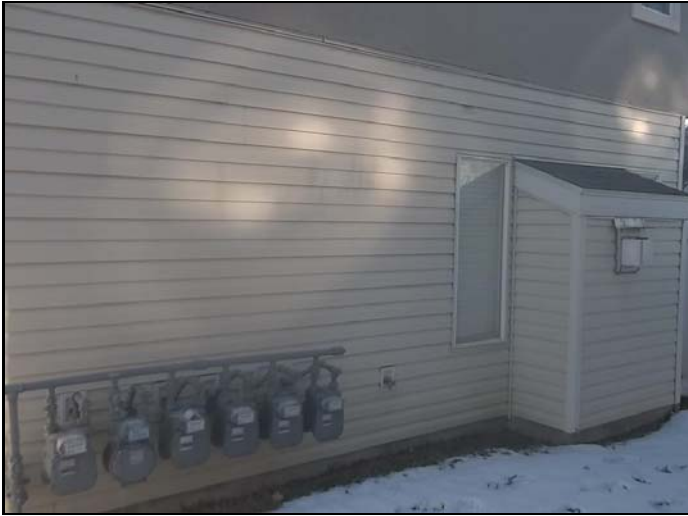
Comp #: 302 Vinyl Siding - Replace

*Location:* **Building Exteriors**

*Quantity:* **Approx 40,510 Sq.ft.**

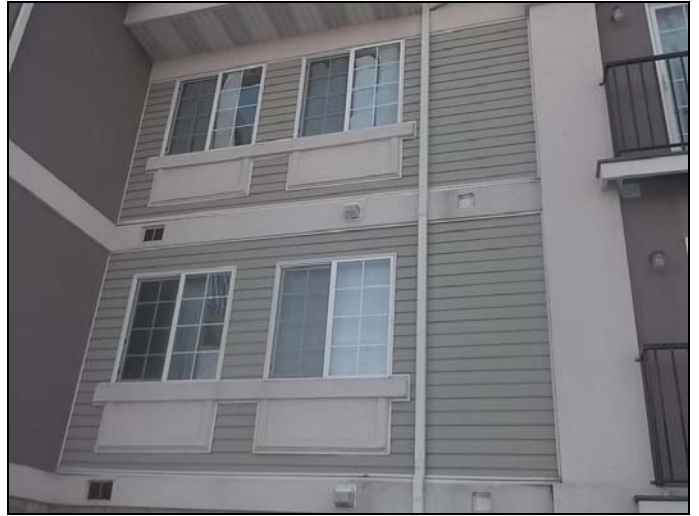
The vinyl siding is in good to fair condition. We recommend funding to replace this component approximately every 40 - 50 years. Remaining life based on average age.

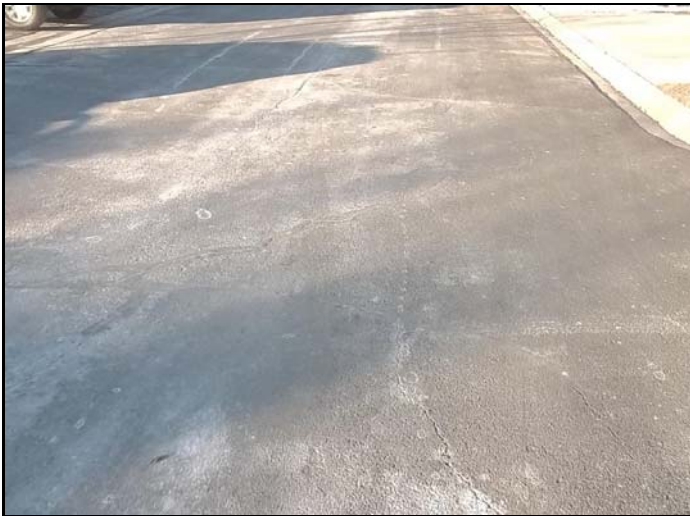
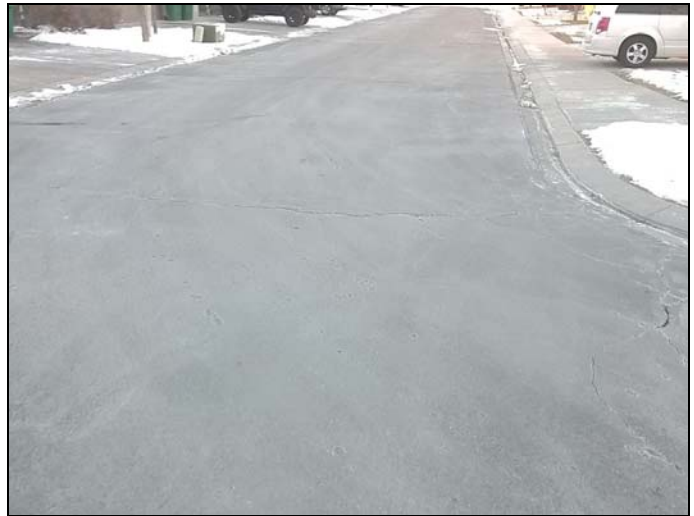
Comp #: 401 Asphalt - Major Rehab

*Location:* **Community Streets**

*Quantity:* **Approx 125,135 Sq.ft.**

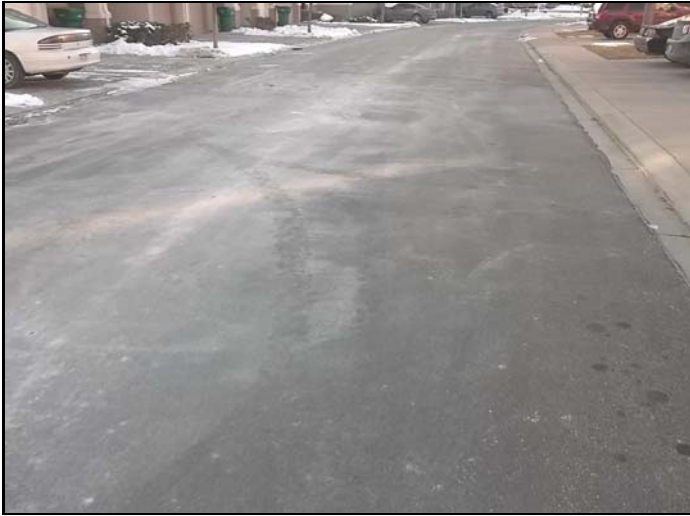
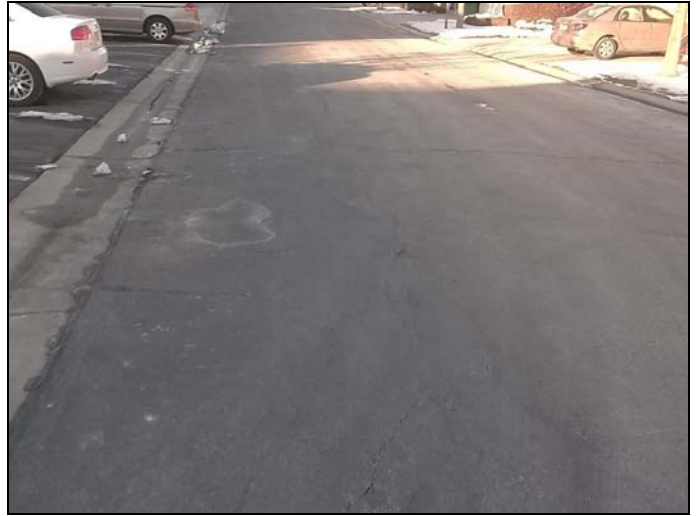
Comp #: 402 Asphalt - Seal Coat

*Location:* **Community Streets**

*Quantity:* **Approx 125,135 Sq.ft.**

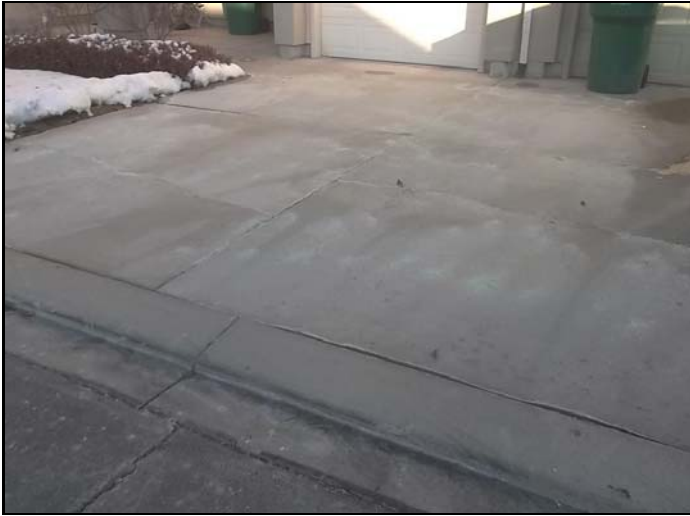
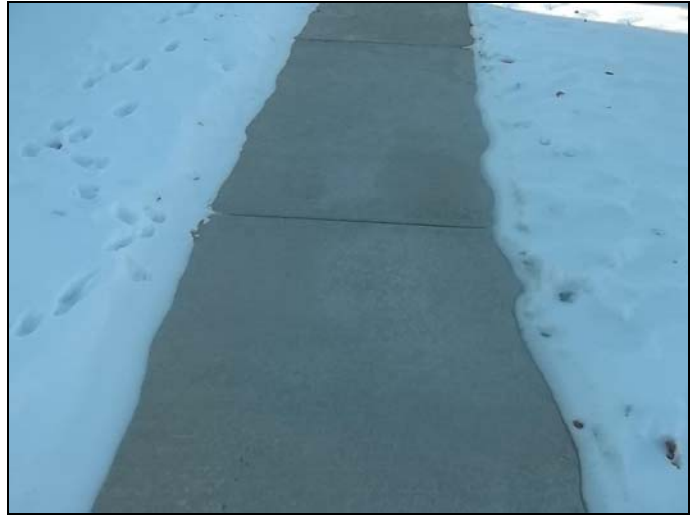
Comp #: 403 Concrete - Partial Repair/Replace

The concrete is generally in good condition. This component has an extended useful life under normal conditions. We recommend funding to make repairs and partially replace this component approximately every 10 years. Remaining life based on current age.

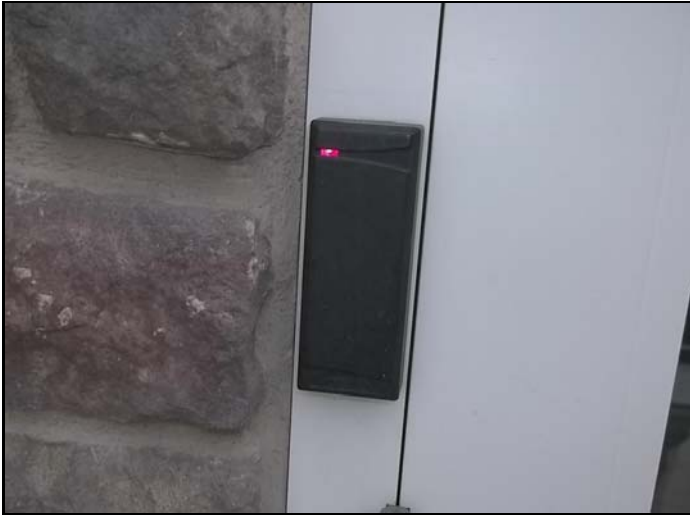
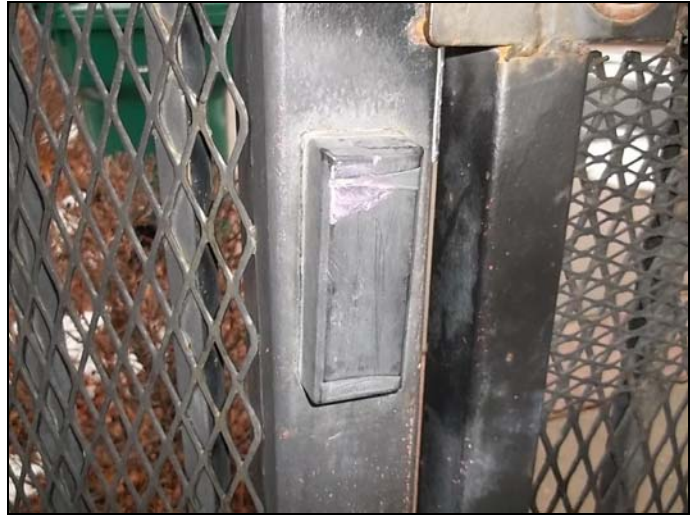
Comp #: 508 Access Control System - Replace

The access control system is in working condition. We recommend funding to replace this component approximately every 10 - 12 years. Remaining life based on current age.

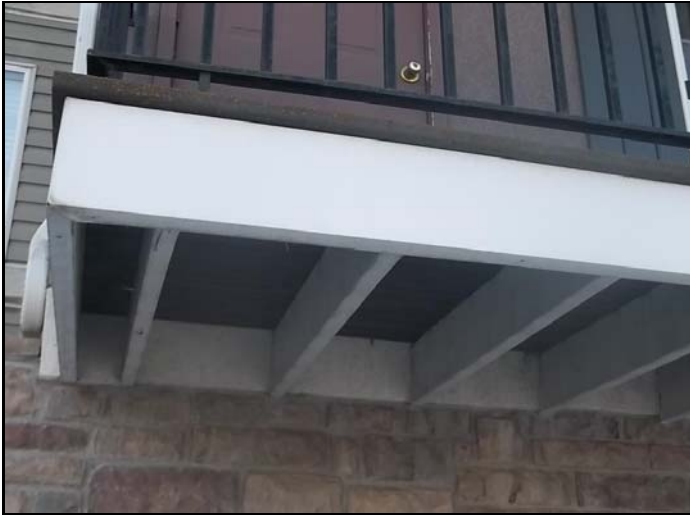
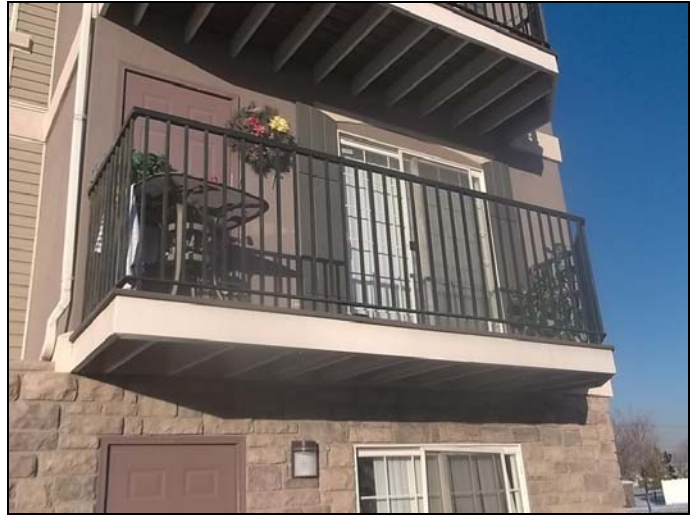
Comp #: 609 Composite Decking - Replace

The composite decking is in good condition. We recommend funding to replace this component approximately every 25 - 30 years. Remaining life based on average age.

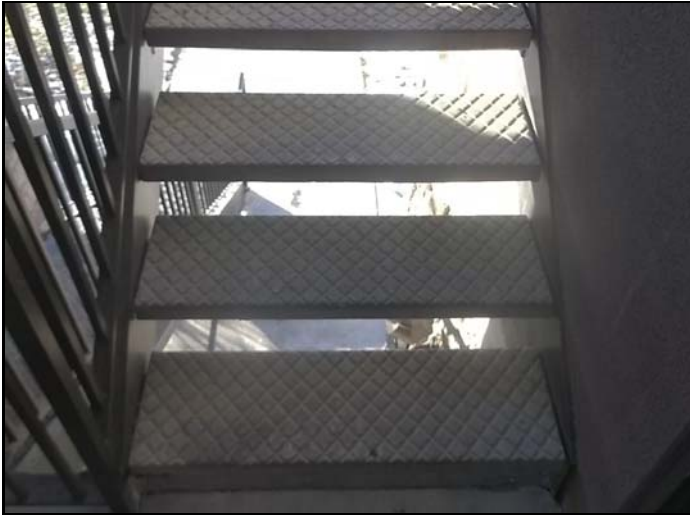
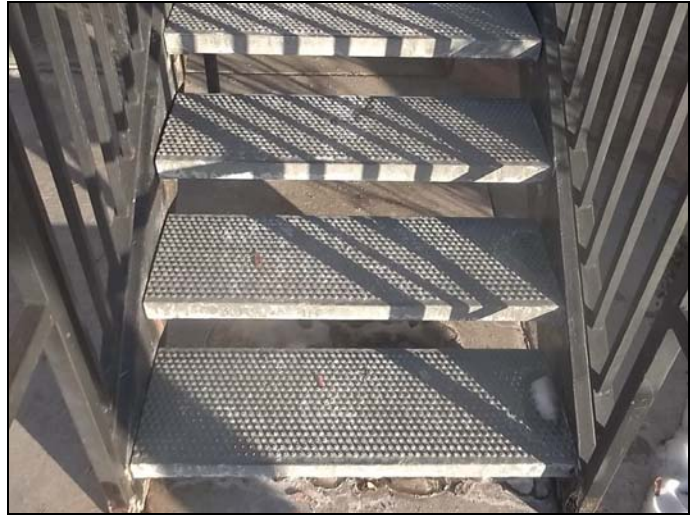
Comp #: 690 Stair Treads - Partial Replace

The stair treads are generally in good condition. Research with the client reveals they replaced treads as necessary each year.

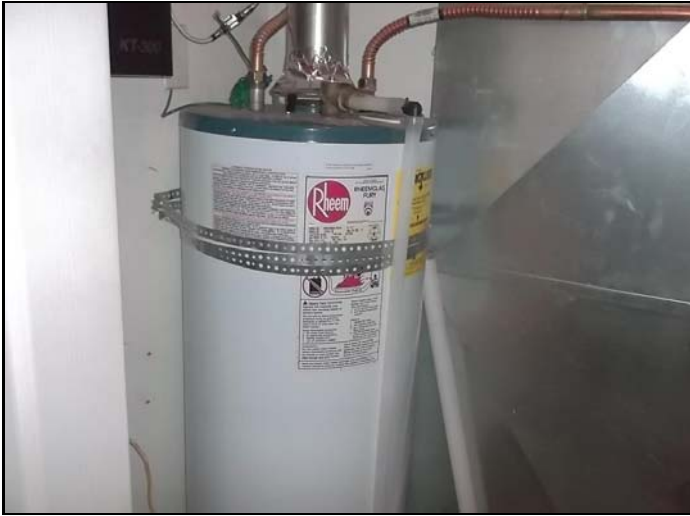
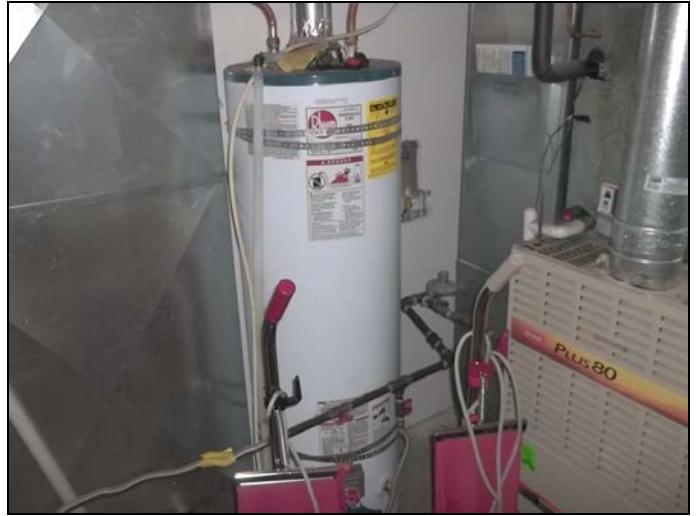
Comp #: 703 Water Heaters - Replace

The water heaters are in working condition. We recommend funding to replace this component approximately every 12 years. Remaining life based on current age.

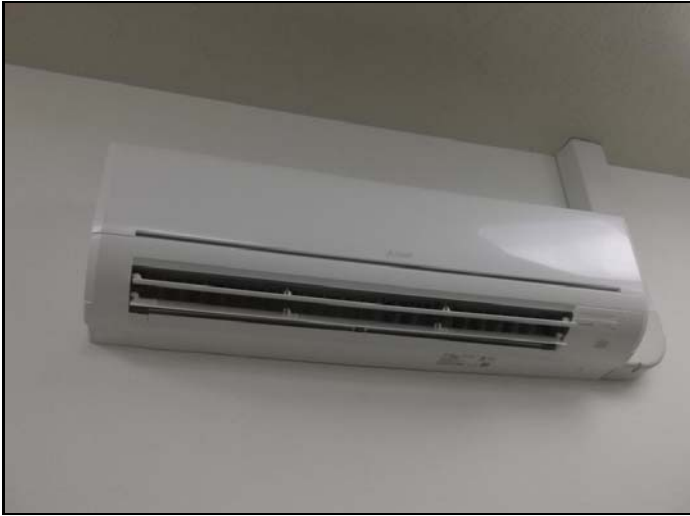
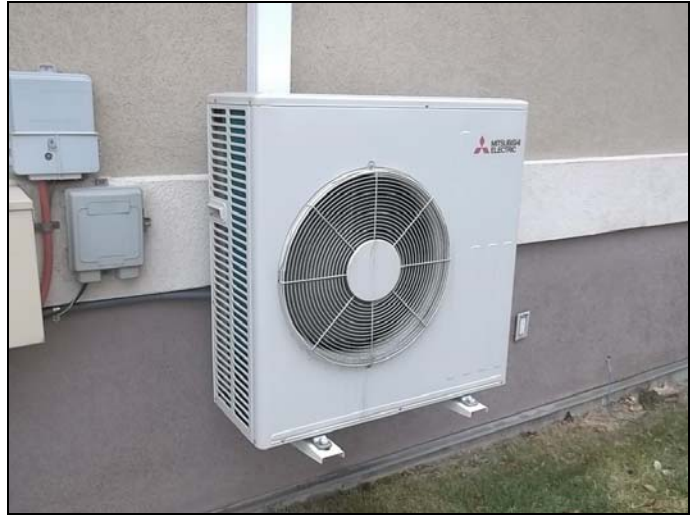
Comp #: 704 Ductless Split HVAC System - Replace

*Location:* **Clubhouse**

*Quantity:* **(1) System**

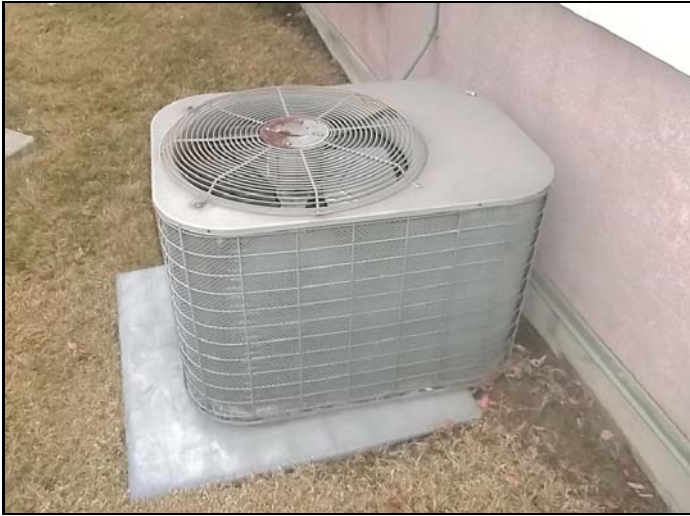
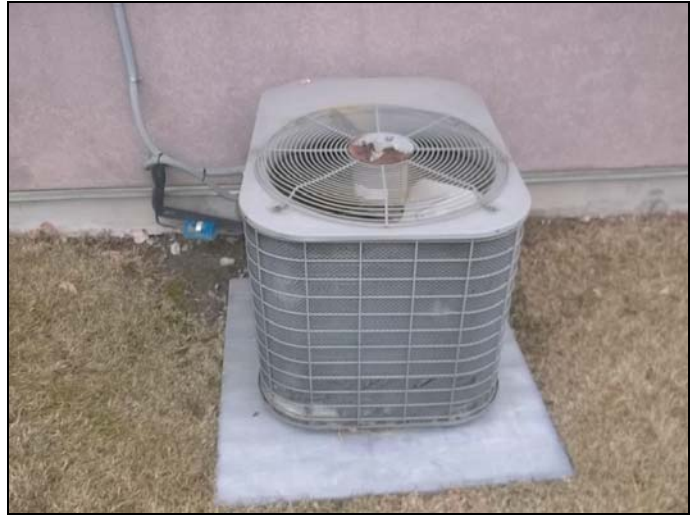
Comp #: 705 HVAC Condenser - Replace

*Location:* **Adjacent to Clubhouse**

*Quantity:* **(1) Condenser**

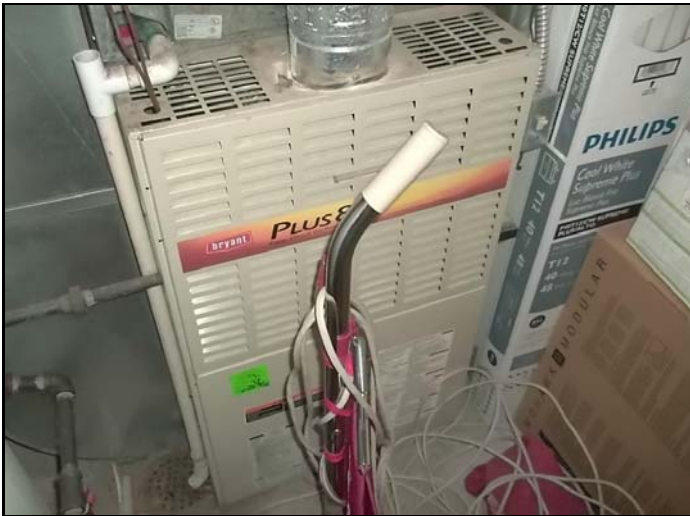
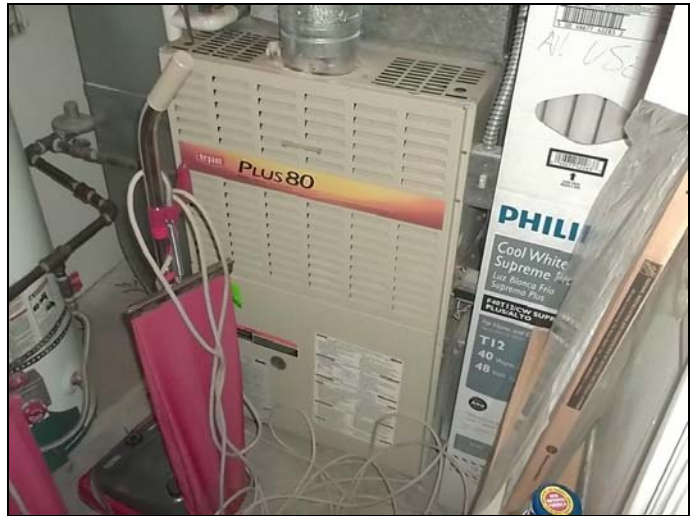
Comp #: 706 HVAC Furnace - Replace

*Location:* Clubhouse Interior

*Quantity:* (1) Furnace

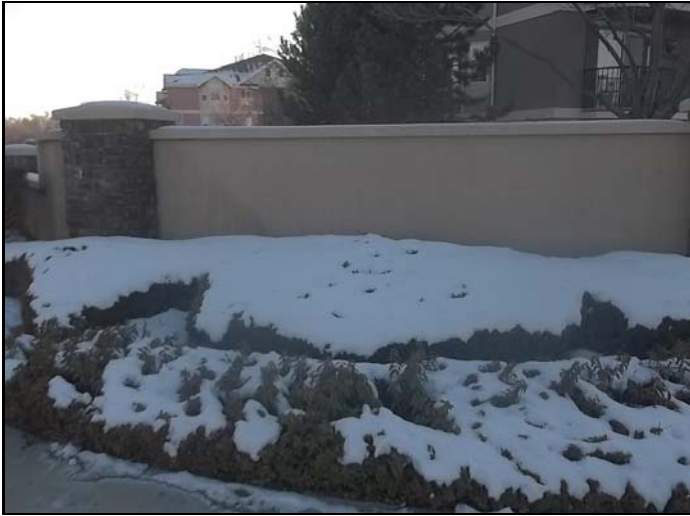
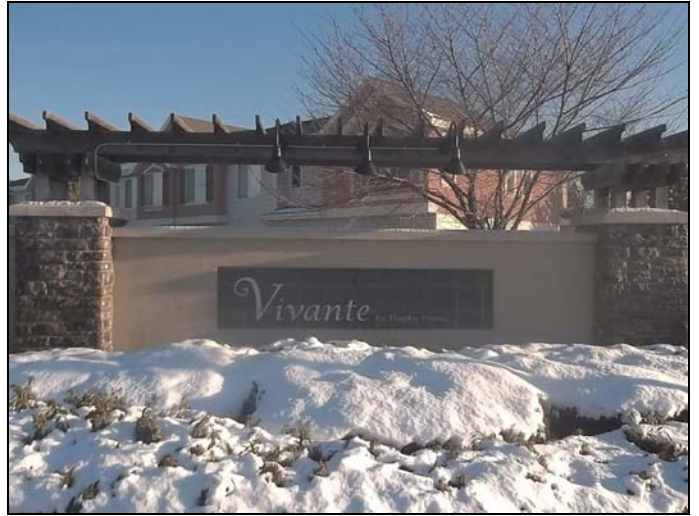
Comp #: 801 Entrance Monuments - Refurbish

*Location:* **Community Entrance**

*Quantity:* **(2) Monuments**

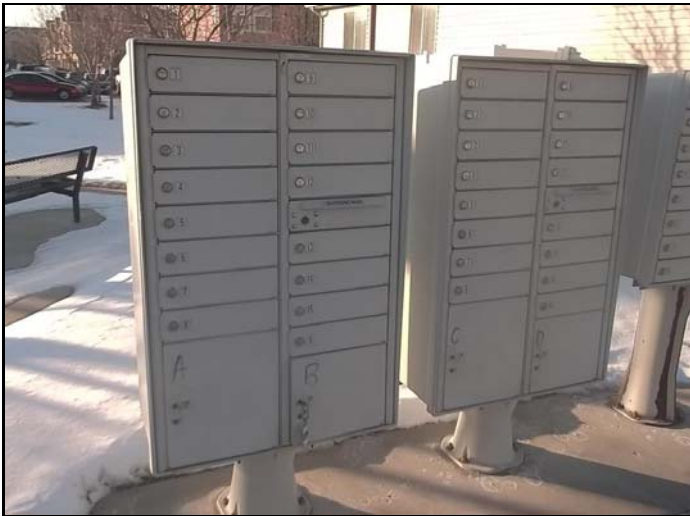
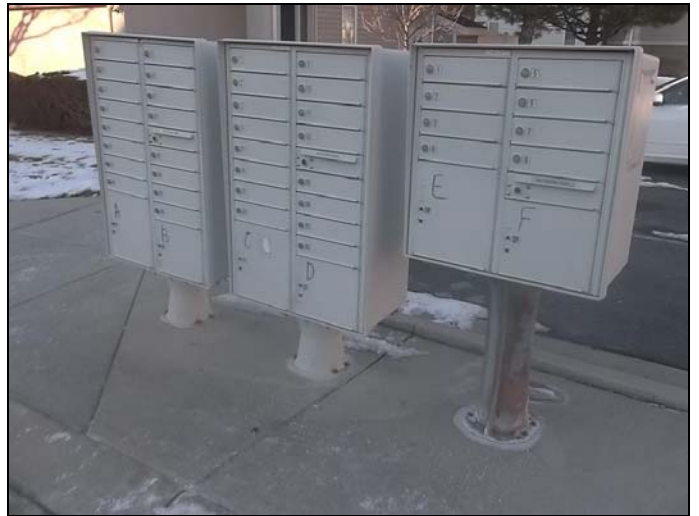
Comp #: 803 Mailboxes - Replace

*Location:* **Common Area**

*Quantity:* **(14) Clusters**

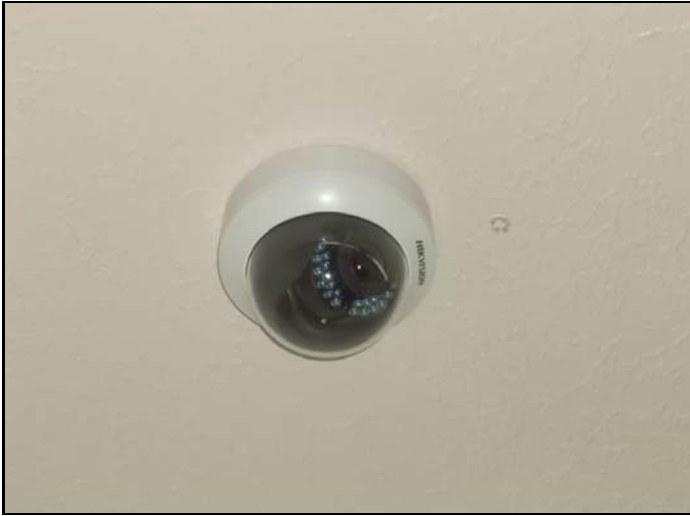
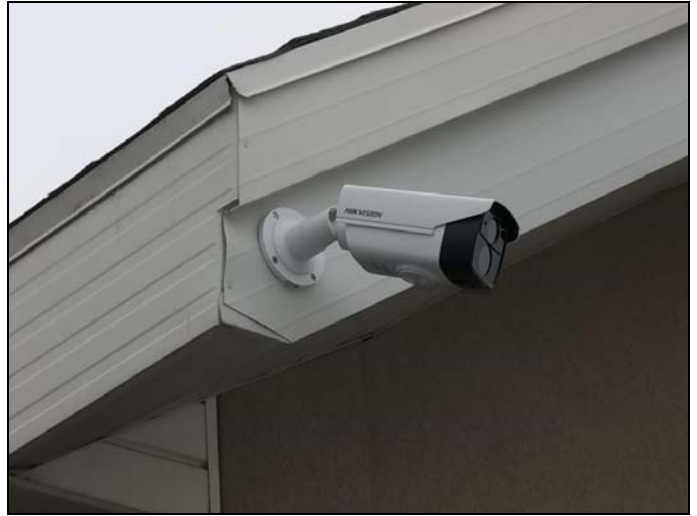
Comp #: 903 Security Camera System - Replace

*Location:* **Clubhouse & Pool Area**

*Quantity:* **(1) System**

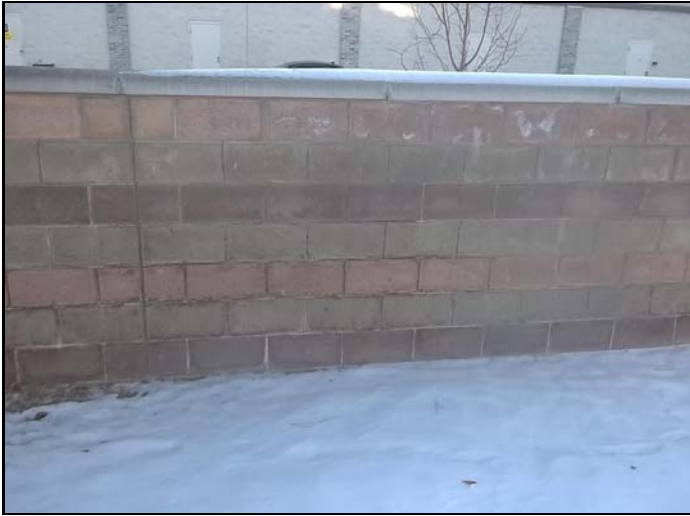
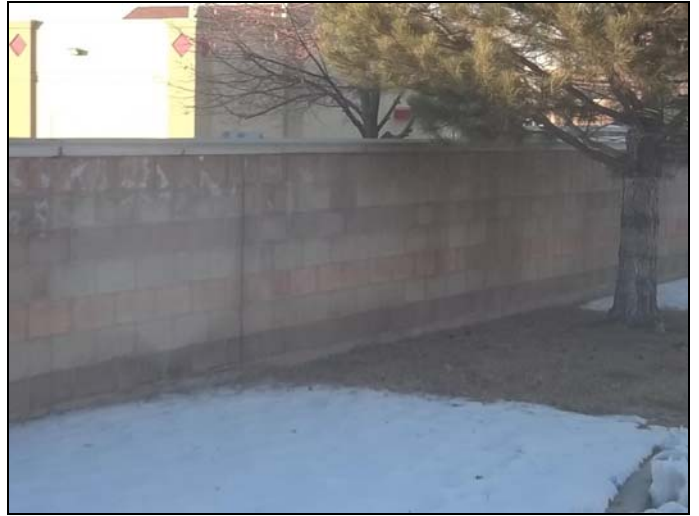
Comp #: 1005 Block Walls - Replace

*Location:* **Community Perimeter**

*Quantity:* **Approx 725 Linear ft.**

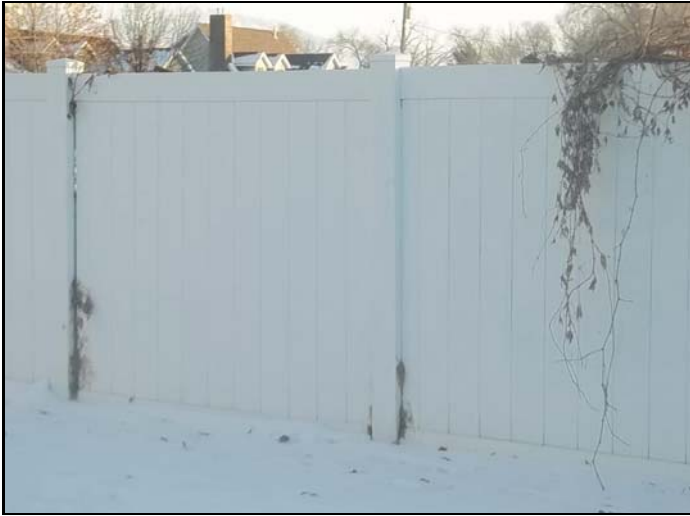
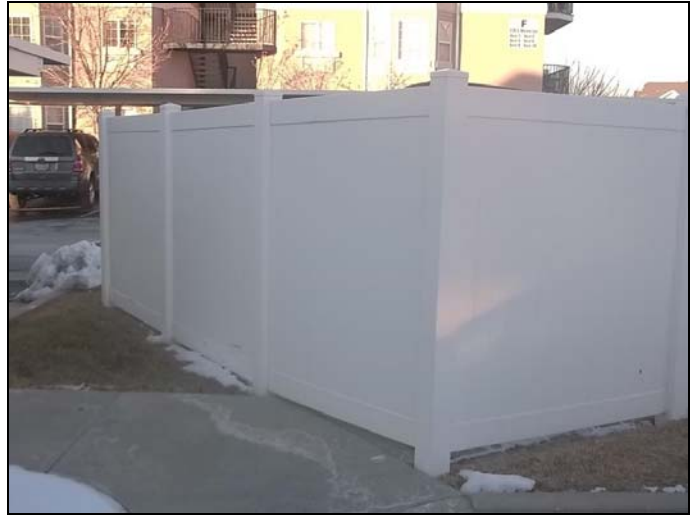
Comp #: 1008 Vinyl Fencing - Replace

*Location:* **Community Perimeter & Yards**

*Quantity:* **Approx 2,880 Linear ft.**

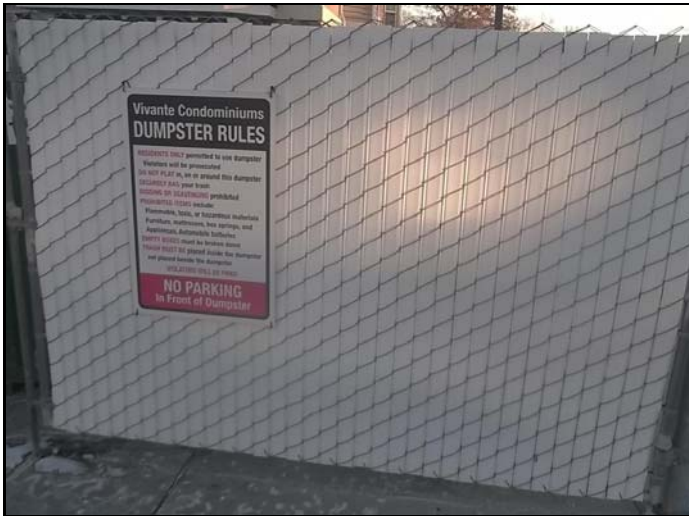
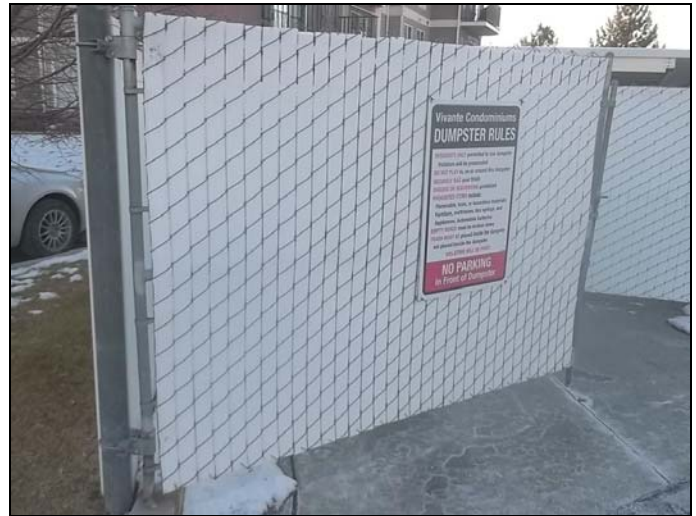
# Comp #: 1010 Dumpster Enclosure Gates - Replace

*Location:* Dumpster Enclosures

*Quantity:* (10) Gates

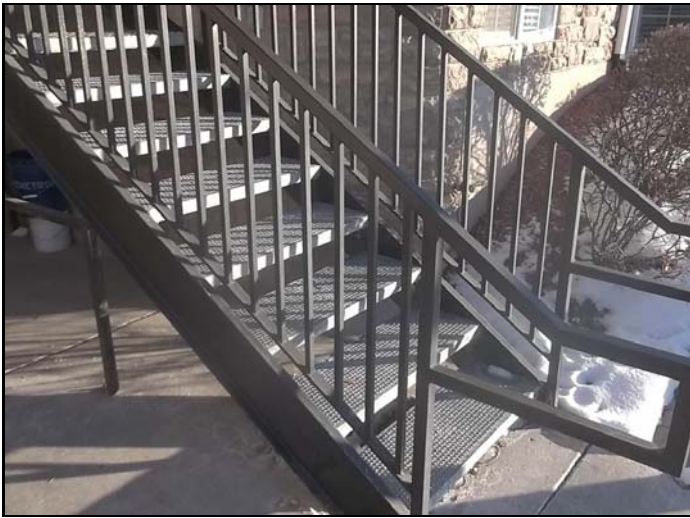
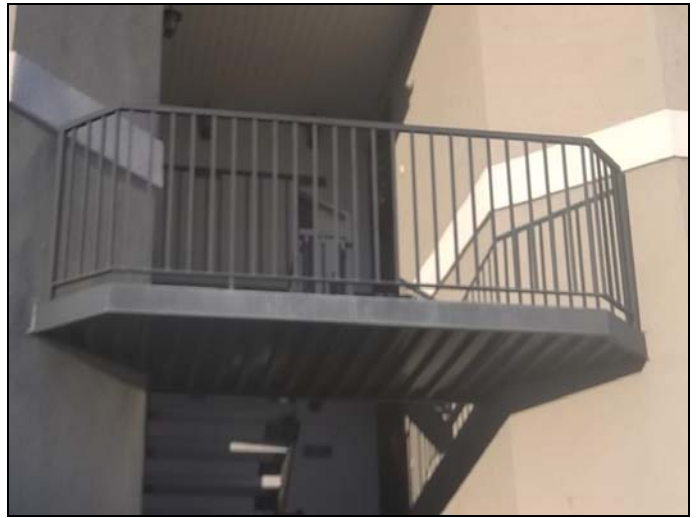
Comp #: 1090 Metal Railing - Replace

*Location:* **Building Stairs & Decks**

*Quantity:* **Approx 4,260 Linear ft.**

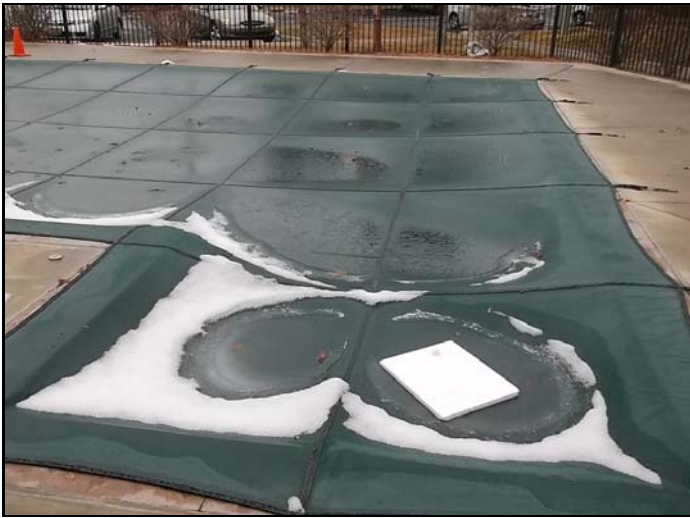
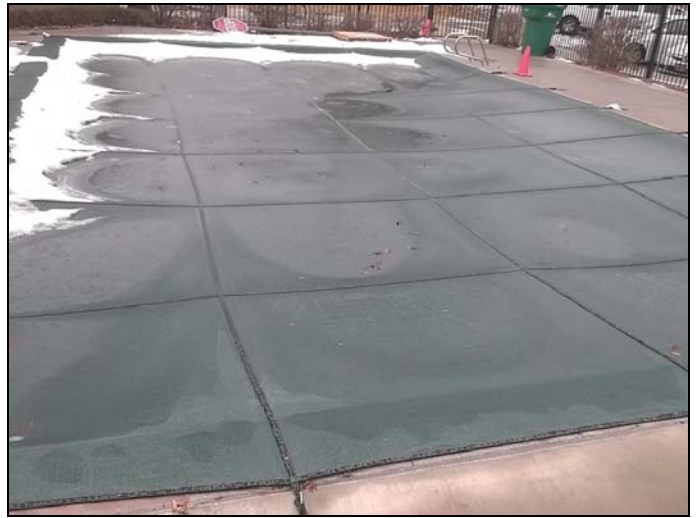
Comp #: 1101 Pool - Resurface

*Location:* **Pool Area**

*Quantity:* **(1) Pool**

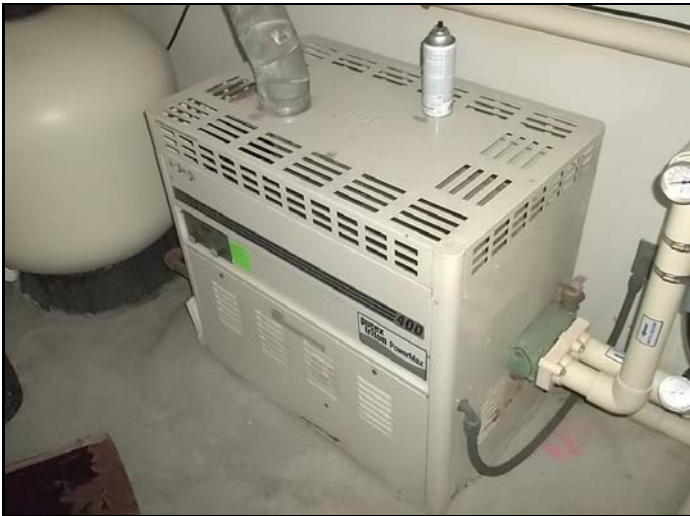
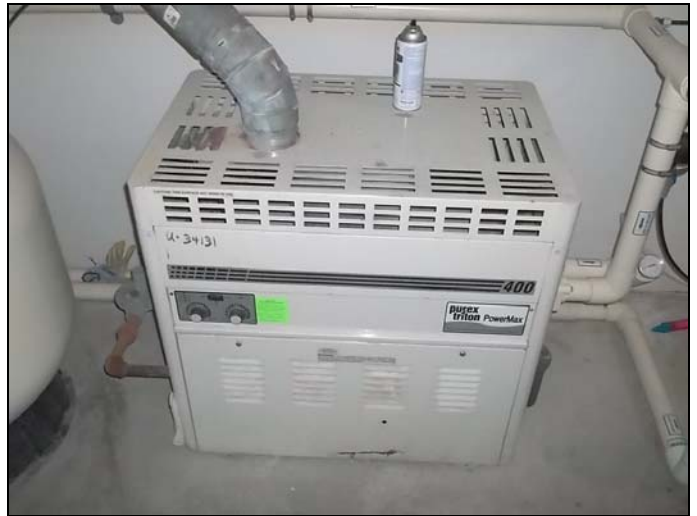
Comp #: 1104 Pool Heater - Replace

*Location:* **Pool Equipment Room**

*Quantity:* **(1) Heater**

The pool heater is in working condition. We recommend funding to replace this component approximately every 12 years. Remaining life based on current age.

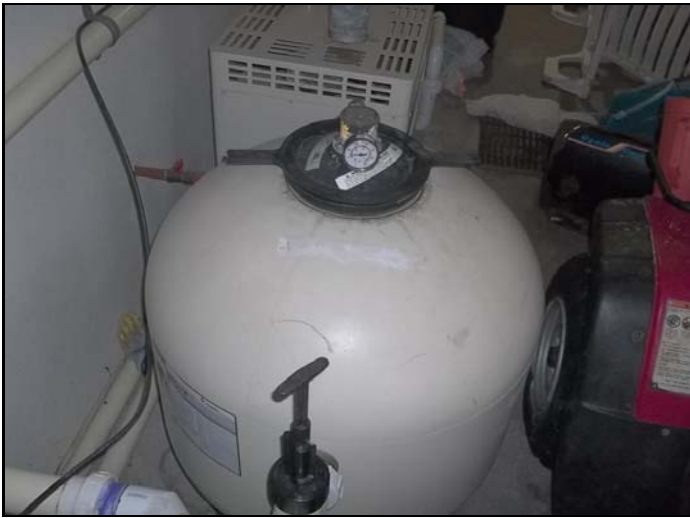
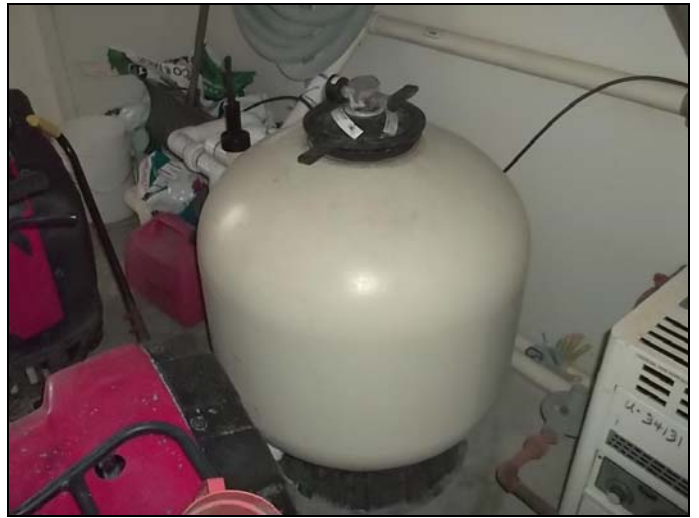
Comp #: 1107 Pool Filter - Replace

*Location:* **Pool Equipment Room**

*Quantity:* **(1) Filter**

The pool filter is in working condition. We recommend funding to replace this component approximately every 12 - 15 years. Remaining life based on current age.

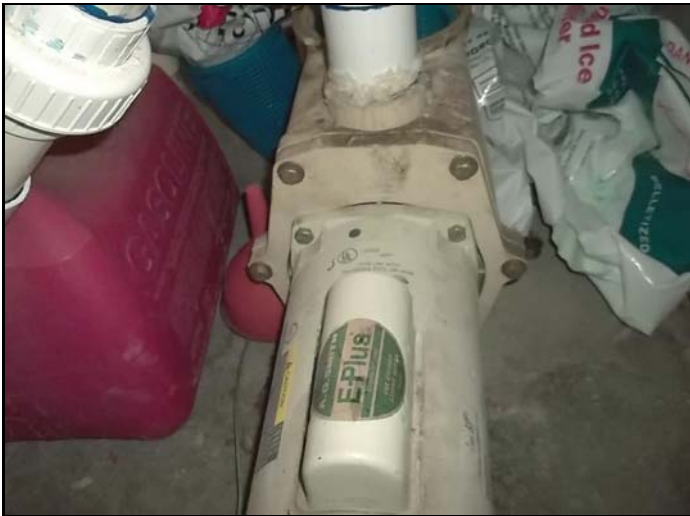
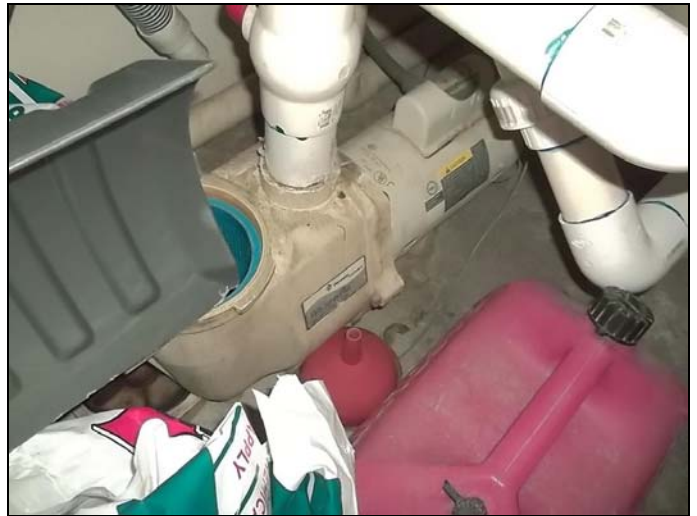
Comp #: 1110 Pool Pump - Replace

*Location:* **Pool Equipment Room**

*Quantity:* **(1) Pump**

The pool pump is in working condition. We recommend funding to replace this component approximately every 8 - 10 years. Remaining life based on current condition.
