# Vivante HOA

## Level 1 Reserve Study

**Report Period – 01/01/2019 – 12/31/2019**

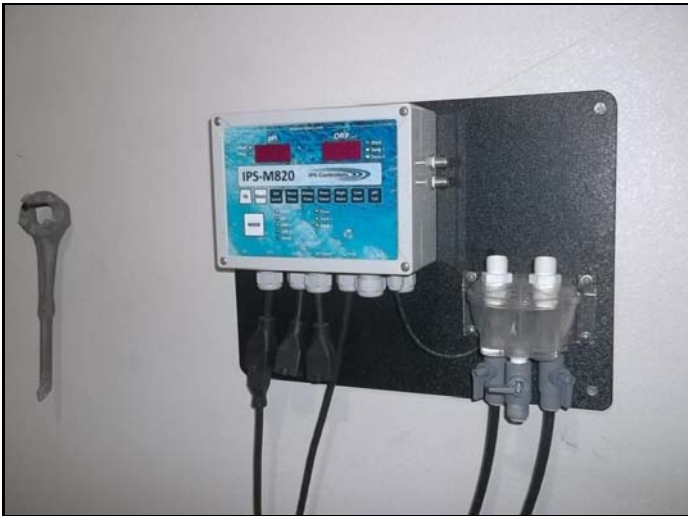
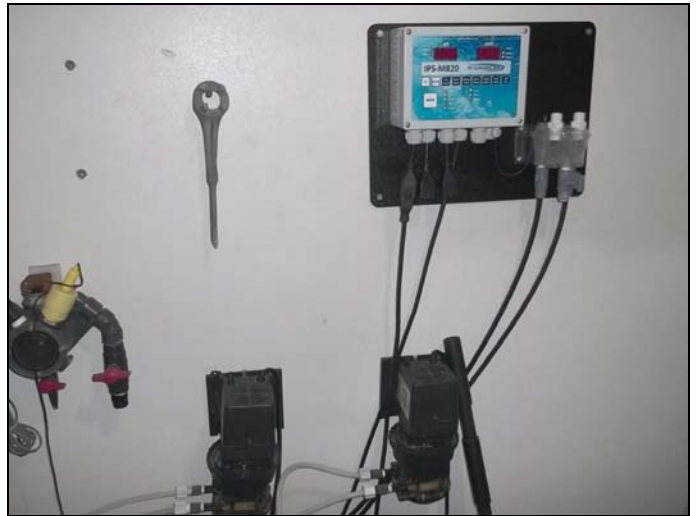
Comp #: 1111 Pool Chemical Controller System - Replace

*Location:* Pool Equipment Room

*Quantity:* (1) System

The pool chemical controller system is in working condition. We recommend funding to replace this component approximately every 10 - 12 years. Remaining life based on current condition.

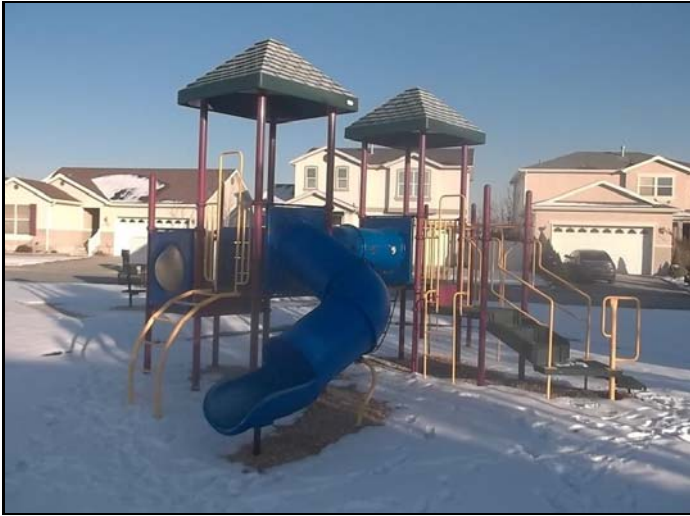
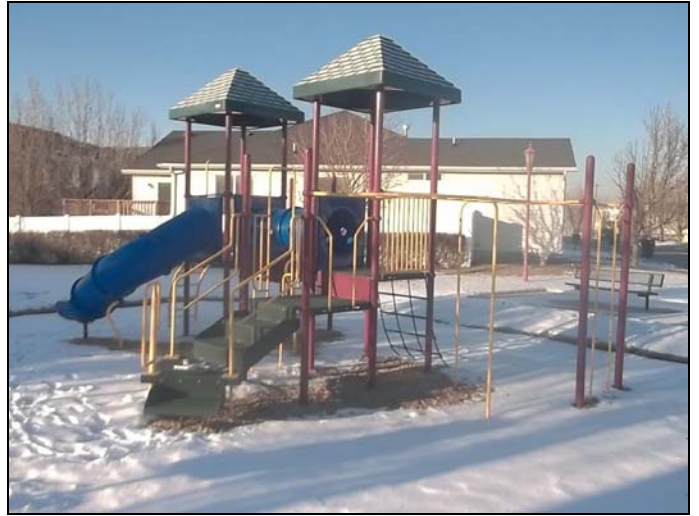
Comp #: 1301 Play Structure - Replace

*Location:* **Play Area**

*Quantity:* **(1) Structure**

The play structure is in good to fair condition. We recommend funding to replace this component approximately every 20 - 25 years. Remaining life based on current age.

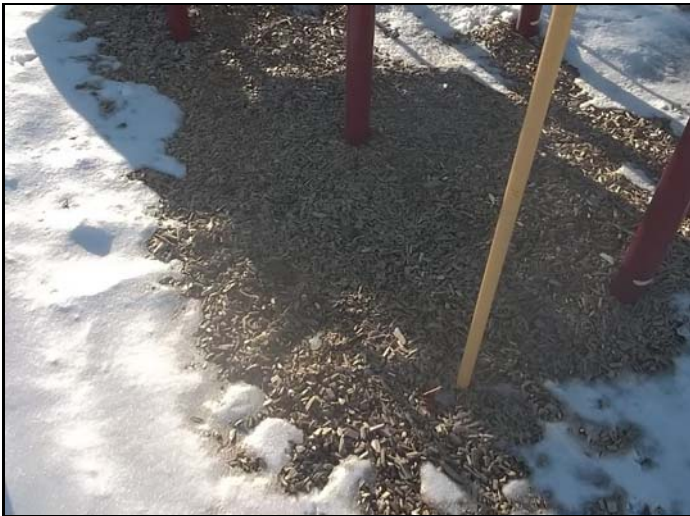
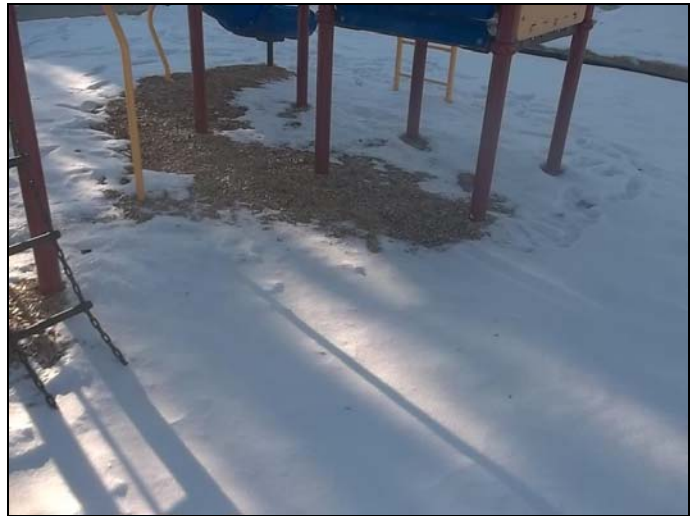
Comp #: 1303 Play Area Groundcover - Refill

*Location:* **Play Area**

*Quantity:* **Approx 1,000 Sq.ft.**

The play area groundcover is in good to fair condition. We recommend funding to refill this component approximately every 3 - 5 years. Remaining life is based on current condition.

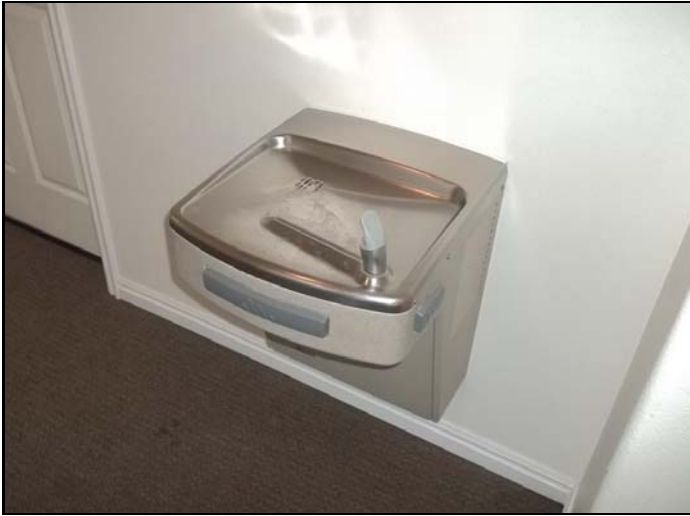
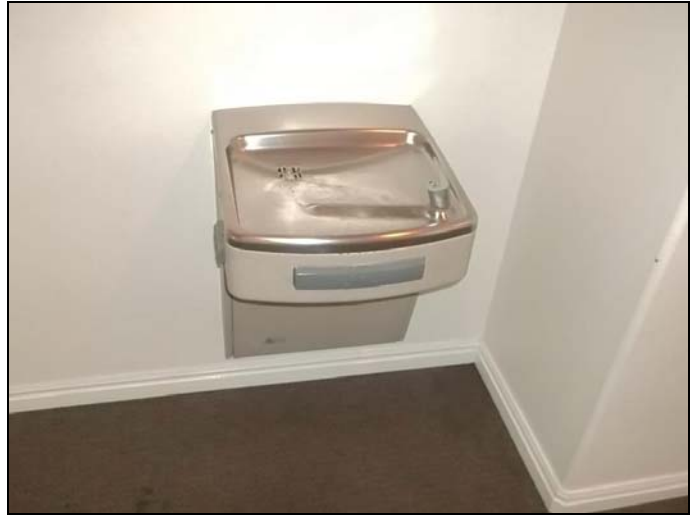
Comp #: 1304 Drinking Fountain - Replace

*Location:* **Clubhouse Interior**

*Quantity:* **(1) Drinking Fountain**

The drinking fountain is in working condition. We recommend funding to replace this component approximately every 10 - 15 years. Remaining life based on current condition.

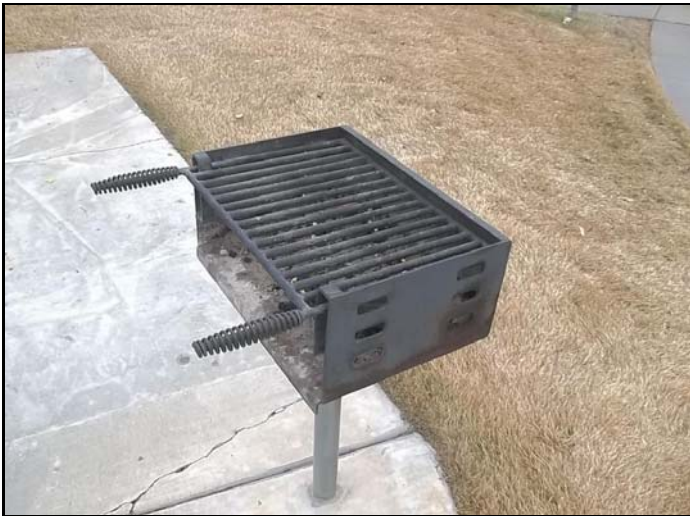
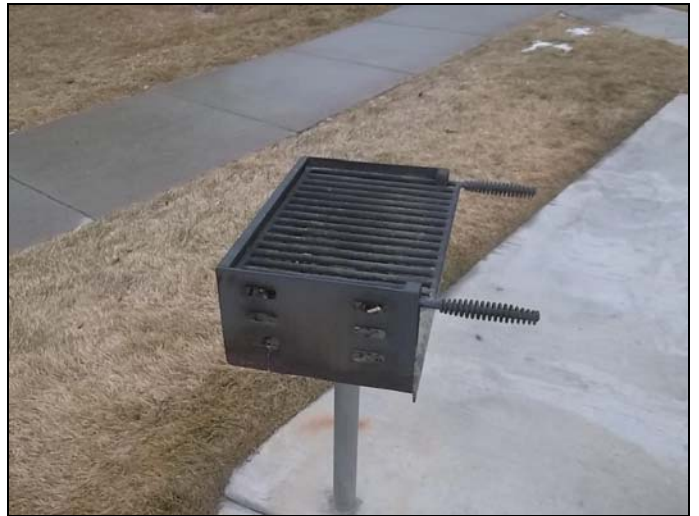
Comp #: 1305 Barbecue Grill - Replace

*Location:* **Clubhouse Grill Area**

*Quantity:* **(1) Grill**

Due to the minimal replacement cost associated with this component, reserve funding is not appropriate. Repair and replace as necessary as an operating expense. No reserve funding necessary.

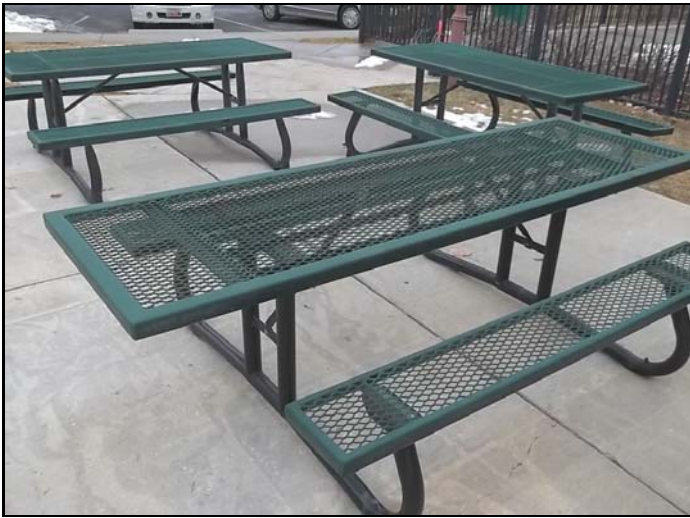
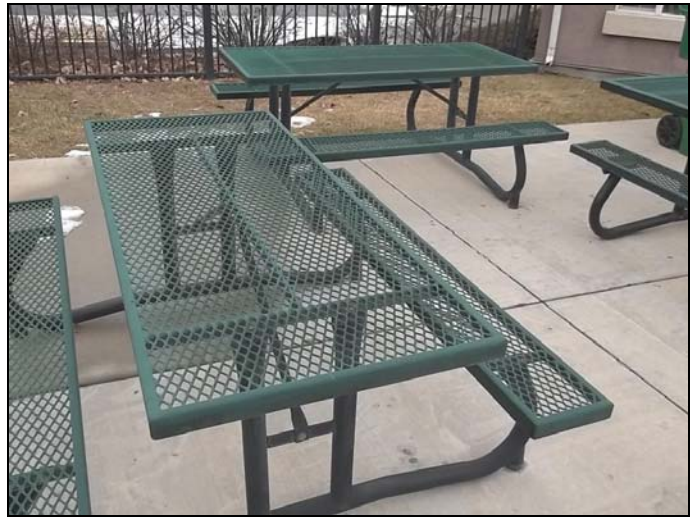
Comp #: 1306 Picnic Tables - Replace

*Location:* **Clubhouse Grill Area**

*Quantity:* **(3) Tables**

The picnic tables are in fair condition. We recommend funding to replace this component approximately every 10 - 15 years. Remaining life based on current condition.

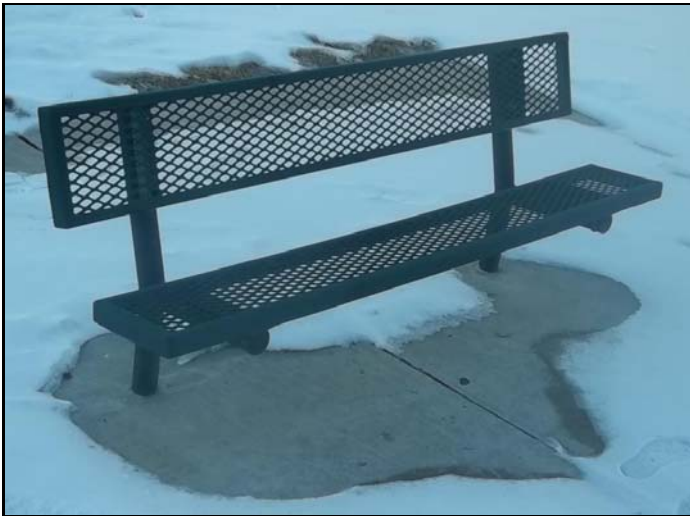
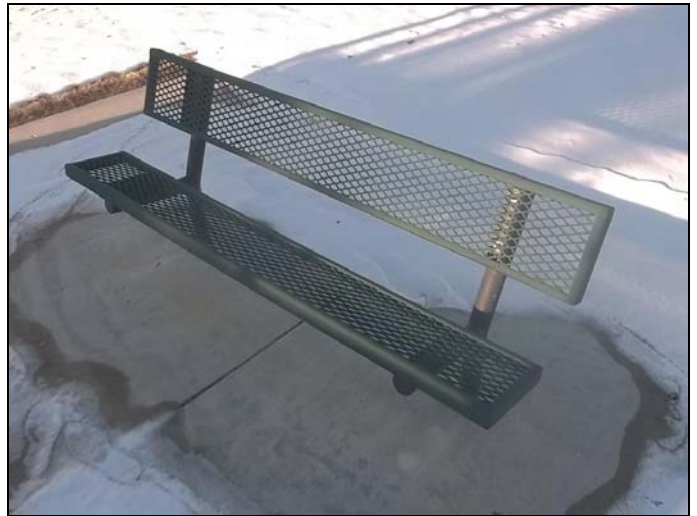
Comp #: 1307 Benches - Replace

*Location:* **Play Area**

*Quantity:* **(2) Benches**

The benches are in fair condition. We recommend funding to replace this component approximately every 10 - 15 years. Remaining life based on current condition.

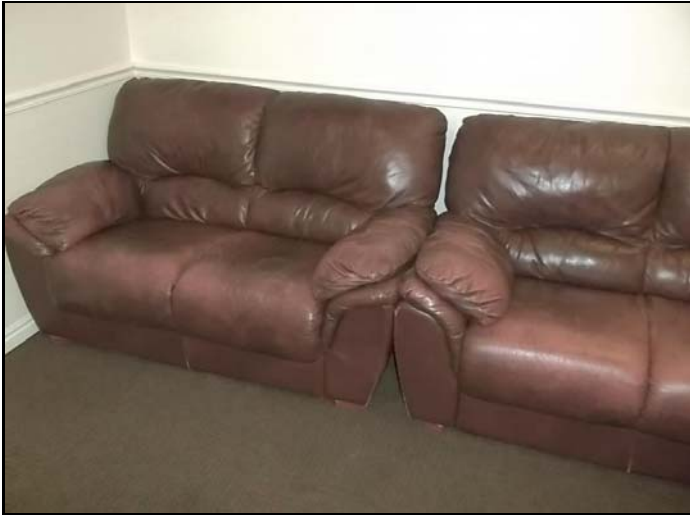
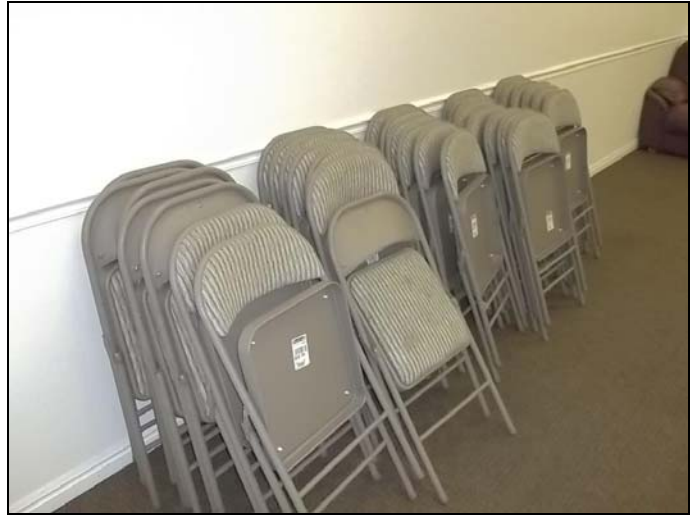
Comp #: 1405 Furniture - Replace

*Location:* **Clubhouse Interior**

*Quantity:* **Assorted Pieces**

The furniture is generally in fair condition. We recommend funding an allowance to make replacements approximately every 10 years. Remaining life based on current average condition.

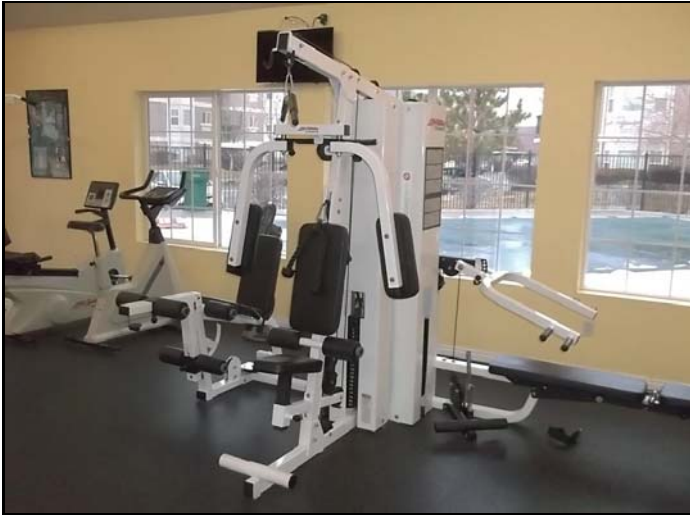
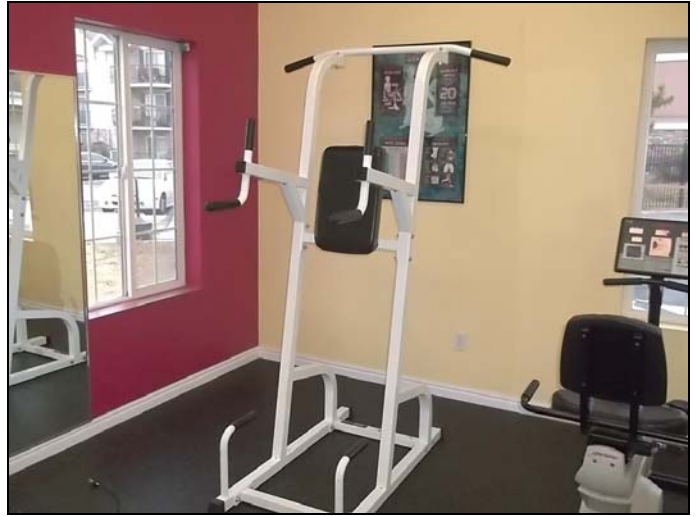
Comp #: 1406 Fitness Equipment - Replace

*Location:* Clubhouse Interior

*Quantity:* (5) Pieces

The fitness equipment is in working condition. We recommend funding to replace this component approximately every 15 years. Remaining life based on current condition.

- (1) - Ab Bench
- (1) - Back Extension
- (1) - Bowflex Extreme
- (1) - Home Gym, 3 Station
- (1) - Pull Up/Chin Up/Dip

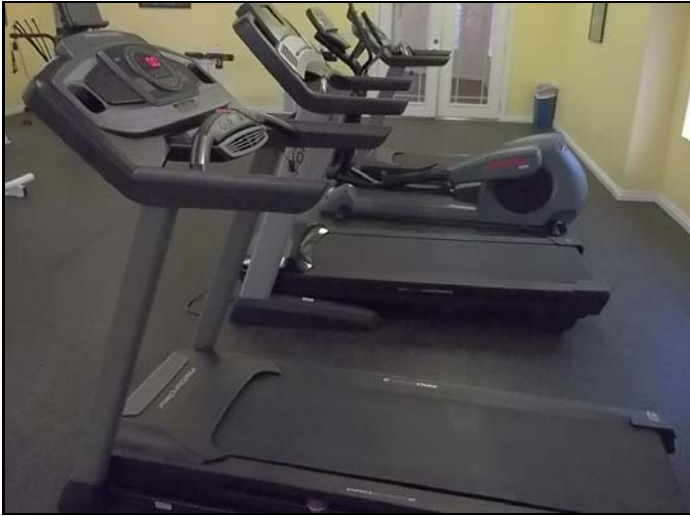
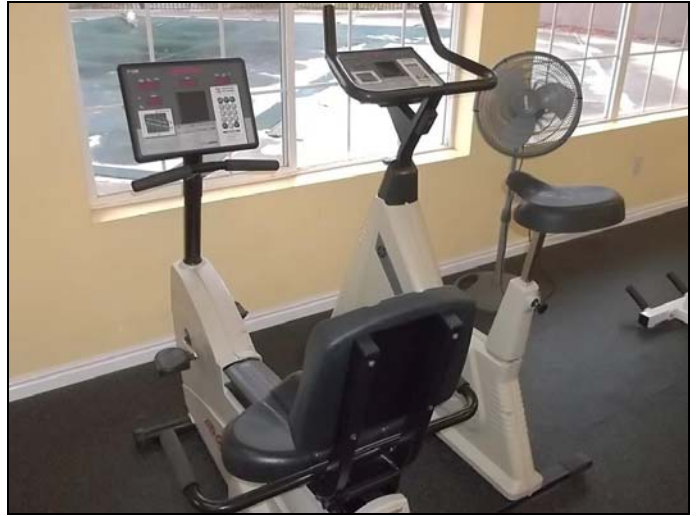
Comp #: 1407 Cardio Equipment - Replace

*Location:* Clubhouse Interior

*Quantity:* (7) Pieces

The cardio fitness equipment is in working condition. We recommend funding to replace this component approximately every 8 years. Remaining life based on average age.

- (1) - Life Fitness Bicycle
- (1) - Life Fitness Bicycle, Recumbent
- (1) - Life Fitness Climber
- (1) - Life Fitness Elliptical
- (3) - Pro Form Treadmill

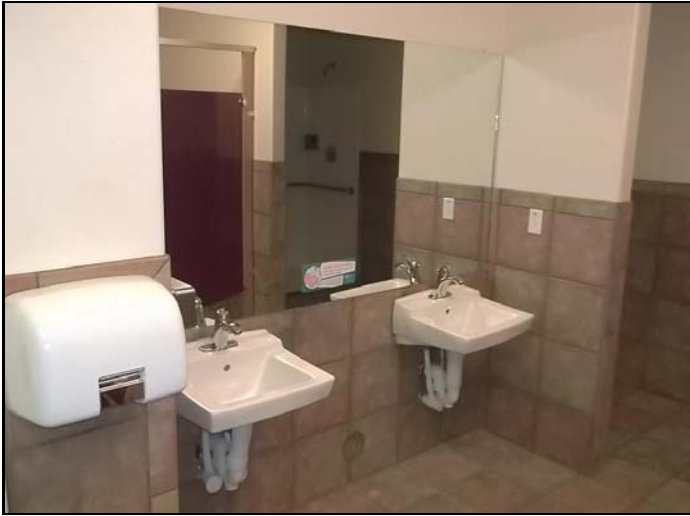
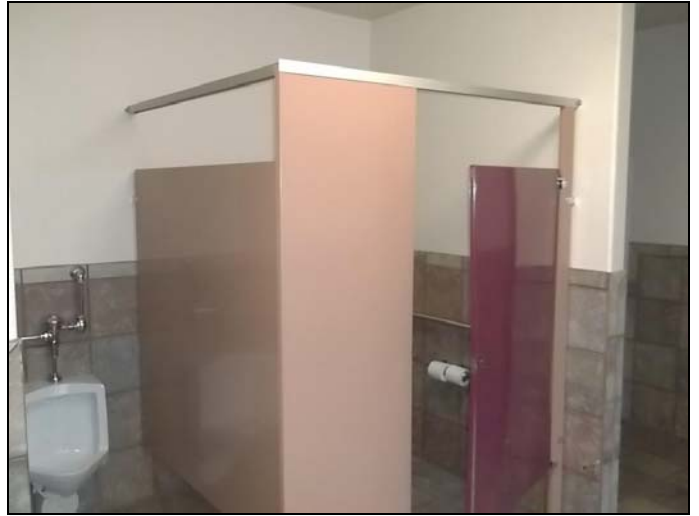
Comp #: 1413 Restrooms - Remodel

*Location:* **Clubhouse Interior**

*Quantity:* **(2) Restrooms**

The restrooms are in fair condition. We recommend funding to remodel this component approximately every 20 years. Remaining life based on current age.

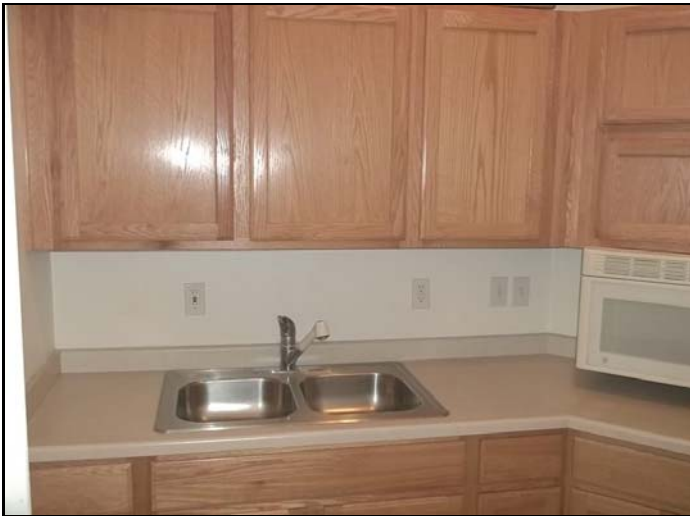
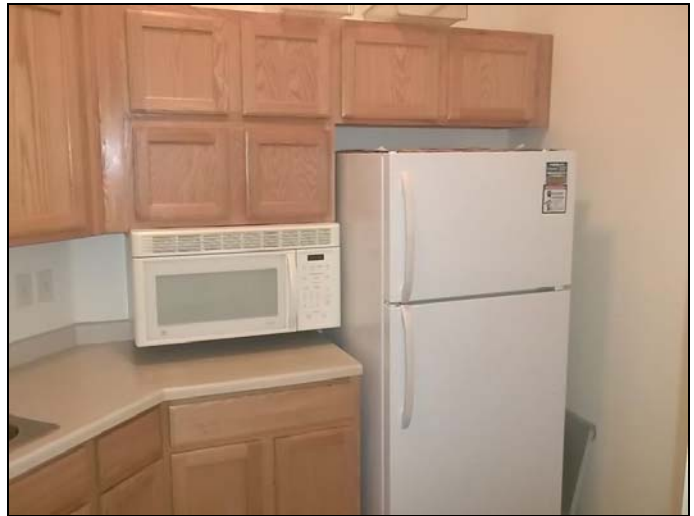
Comp #: 1417 Kitchenette - Remodel

*Location:* **Clubhouse Interior**

*Quantity:* **(1) Kitchenette**

The kitchen is in fair condition. We recommend funding to remodel this component approximately every 20 years. Remaining life based on current age.

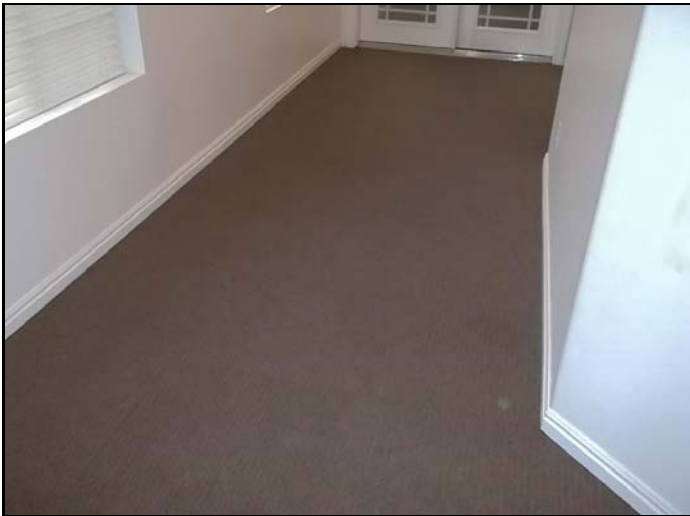
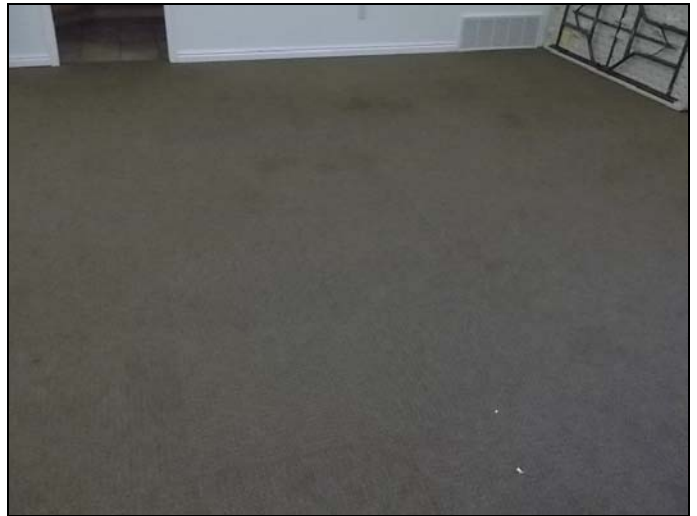
Comp #: 1501 Carpeting - Replace

*Location:* **Clubhouse Interior**

*Quantity:* **Approx 1,110 Sq.ft.**

The carpeting is in fair condition. We recommend funding to replace this component approximately every 8 - 10 years. Remaining life based on current condition.

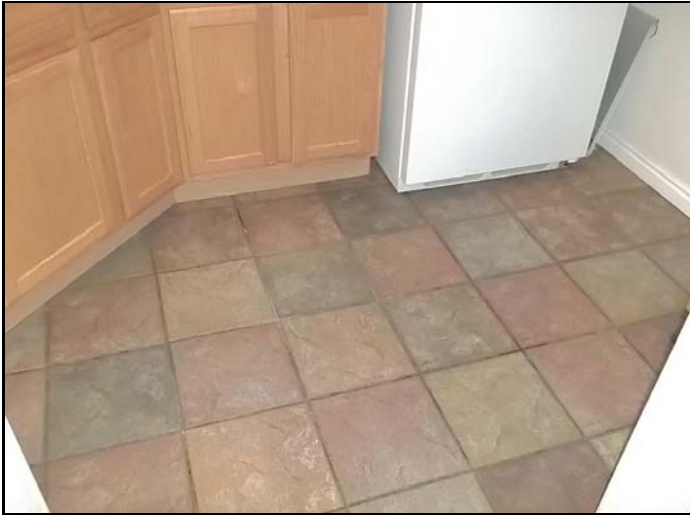
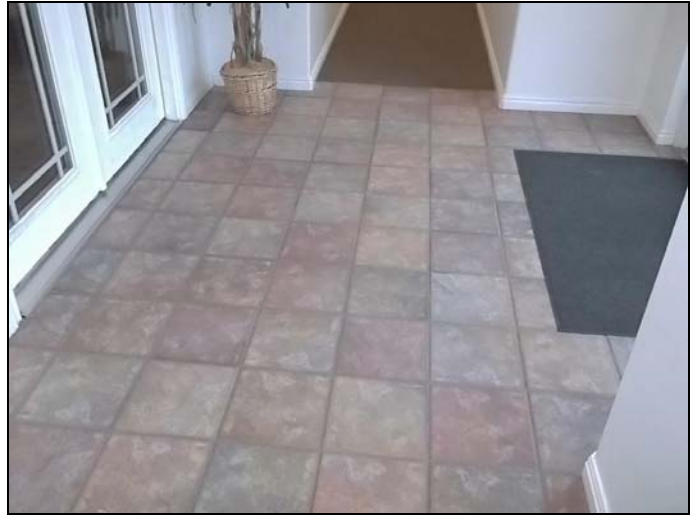
Comp #: 1503 Tile Flooring - Replace

*Location:* **Clubhouse Interior**

*Quantity:* **Approx 600 Sq.ft.**

The tile flooring is in good condition. We recommend funding to replace this component approximately every 30 years. Remaining life based on current age.

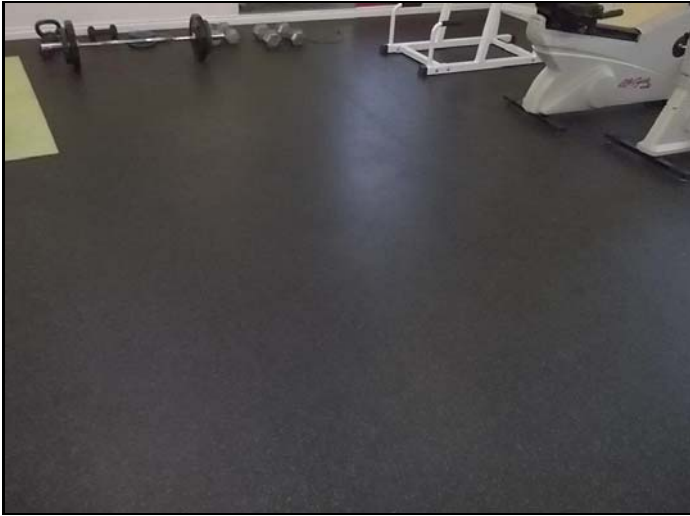
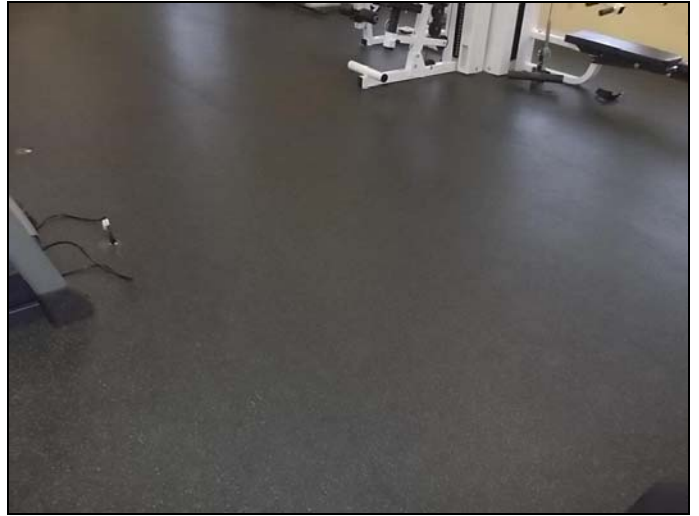
Comp #: 1590 Gym Flooring - Replace

*Location:* **Clubhouse Interior**

*Quantity:* **Approx 1,225 Sq.ft.**

The rubber safety flooring is in good to fair condition. We recommend funding to replace this component approximately every 15 - 20 years. Remaining life based on current age.

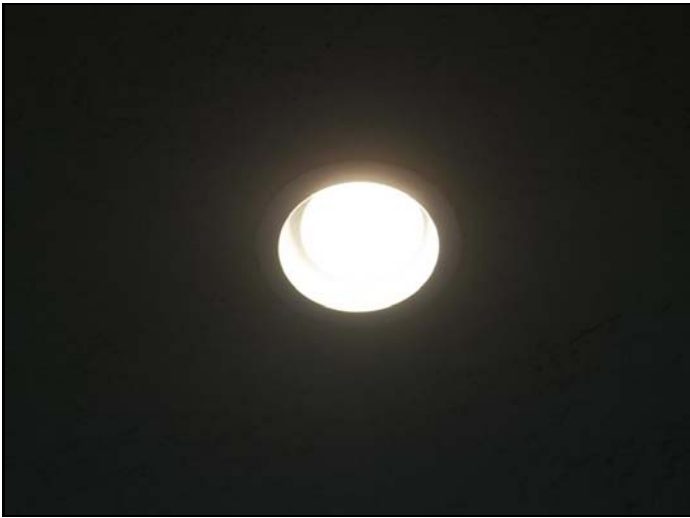
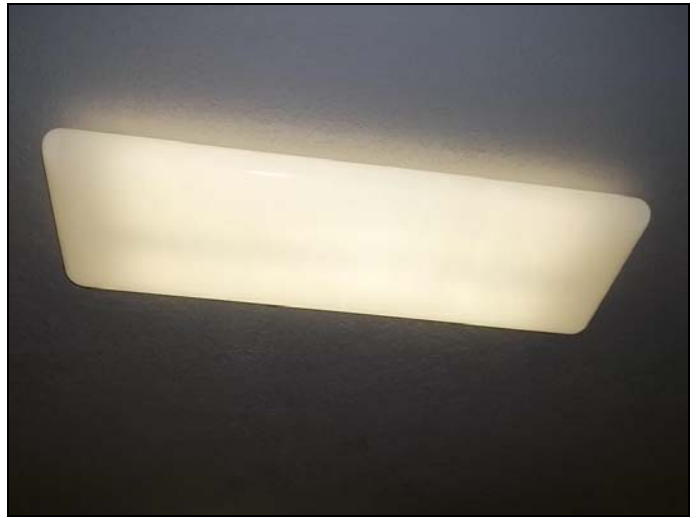
Comp #: 1601 Interior Light Fixtures - Replace

*Location:* Clubhouse Interior

*Quantity:* (42) Fixtures

The interior light fixtures are in good condition. We recommend funding to replace this component approximately every 20 - 25 years. Remaining life based on current age.

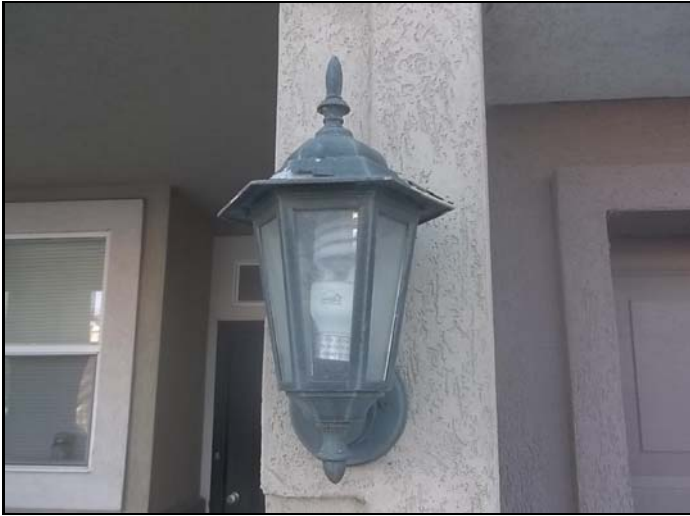
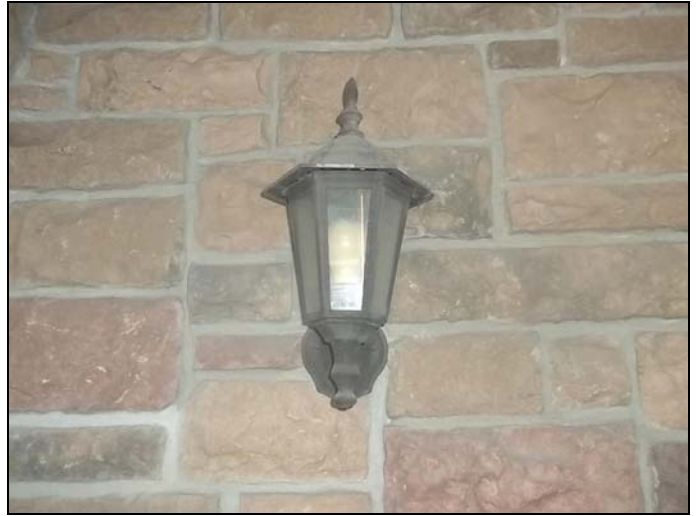
Comp #: 1602 Exterior Light Fixtures - Replace

*Location:* **Building Exteriors**

*Quantity:* **(561) Fixtures**

The exterior light fixtures are in fair to poor condition. We recommend funding to replace this component approximately every 16 - 20 years. Remaining life based on average age.

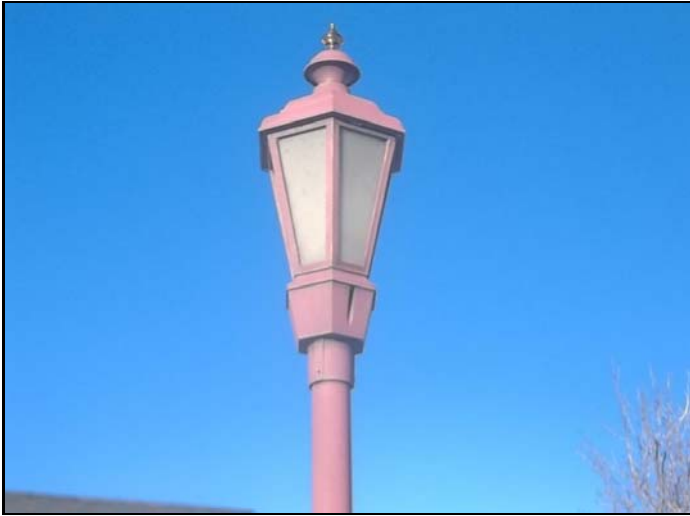
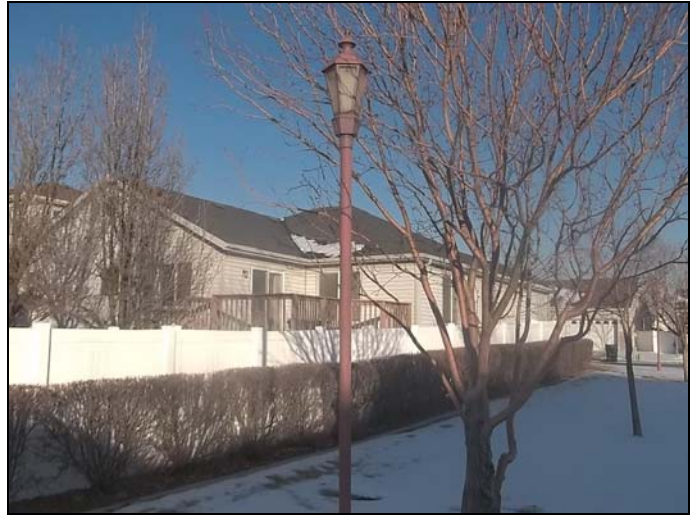
Comp #: 1609 Street Light Fixtures - Replace

*Quantity:* **(21) Fixtures**

The street light fixtures are in fair condition. No expectation to replace the light poles. Paint poles as necessary as an operating expense. We recommend funding to replace this component approximately every 20 years to ensure proper function. Remaining life based on average age.

*Best Cost:* **\$13,650**  
\$650/Fixture; Estimate to replace

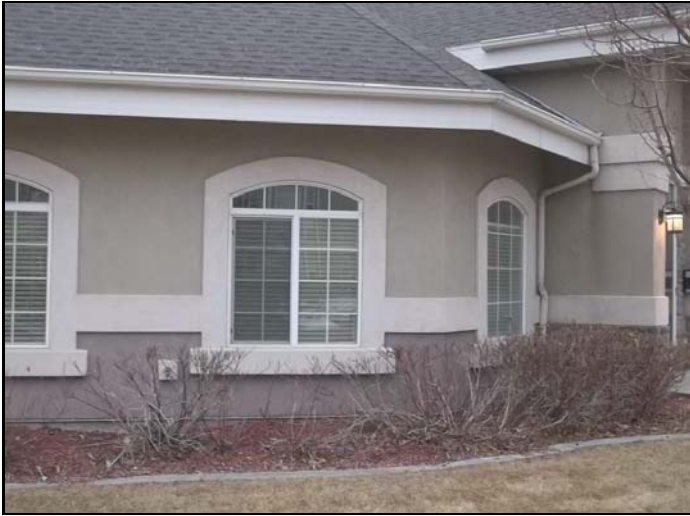
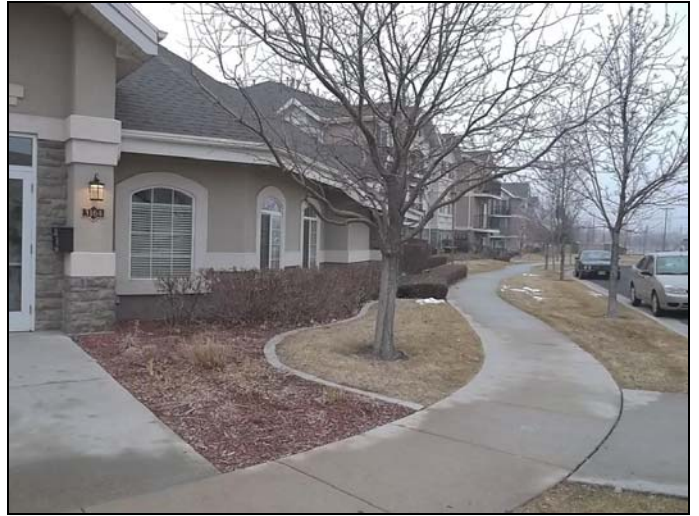
Comp #: 1812 Landscaping & Irrigation System - Renovate

The landscaping and irrigation system are in good condition. We recommend funding for an allowance to renovate the landscaping and irrigation system approximately every 20 years. Remaining life based on average age.
